February 24, 2025

Casa del Sol Circle  
33761 Seabell Rd,  
Sanibel, FL 33957

Regarding: Casa del Sol Condominiums – Phase I Milestone Inspection

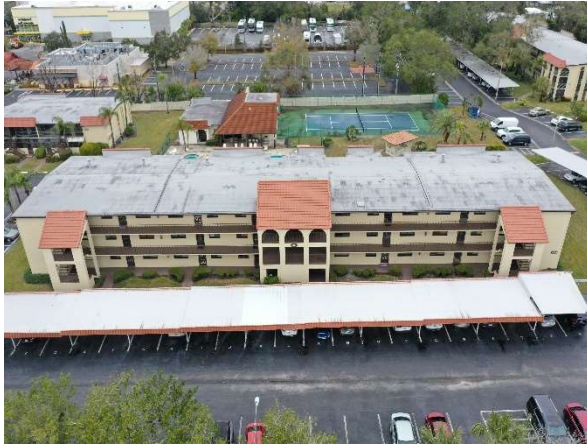
**Photo 1**  
Building Alhambra – Overall view.

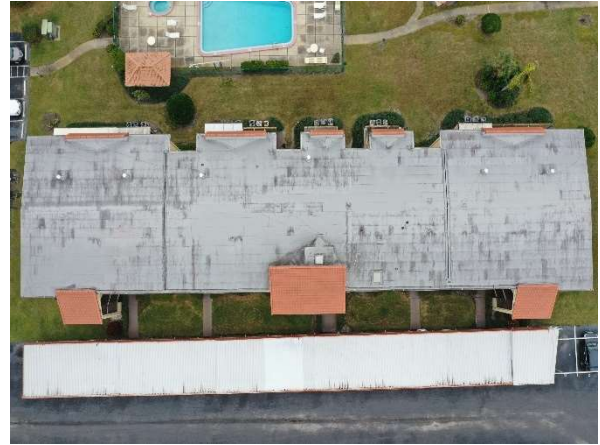
**Photo 4**  
Building Alhambra – Roof – Overall view.

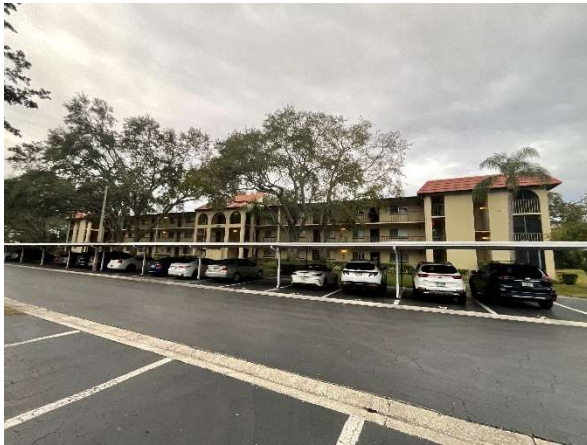
**Photo 2**  
Building Barcelona – Overall view.

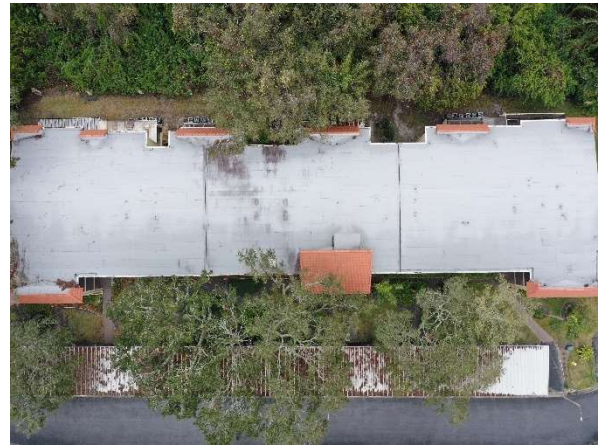
**Photo 5**  
Building Barcelona – Roof – Overall view.

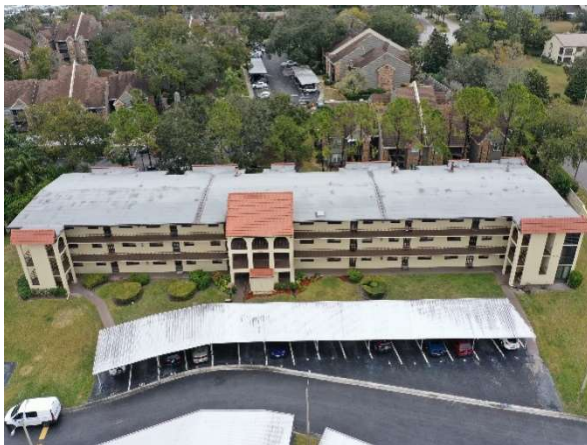
**Photo 3**  
Building Cadiz – Overall view.

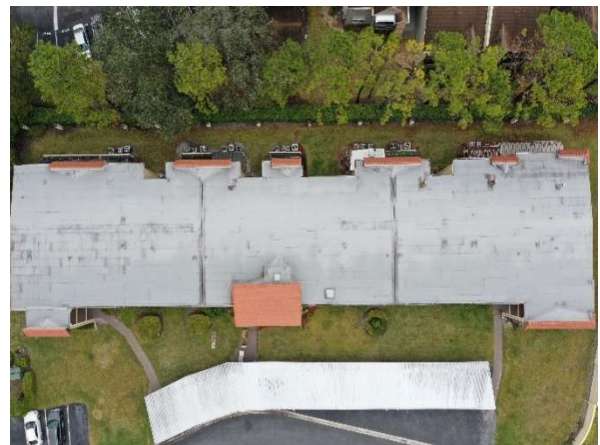
**Photo 6**  
Building Cadiz – Roof – Overall view.

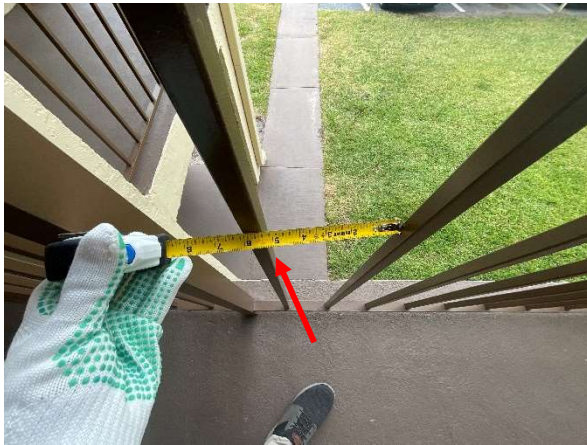
- 2.1.1 BECI identified safety concerns regarding the guardrails at Buildings Alhambra, Barcelona, & Cadiz. The spacing between the guardrail pickets exceeded the maximum allowable limit of 4 inches, as specified in the Florida Building Code 8<sup>th</sup> edition, Section 1015.4 – Opening limitations. This creates potential safety hazards for occupants, visitors and staff. Due to the age of the buildings, the current railing configurations may have been acceptable at the time of construction but do not meet current code requirements. ***BECI recommends these requirements be taken into consideration for the next exterior restoration project to ensure compliance with the Florida Building Code 8<sup>th</sup> Edition*** (Reference Photo Exhibit Nos. 7 through 9).

**Photo 7**  
 Building Cadiz – 2nd Floor – Overall view of spacing between guardrail pickets greater than 4”.

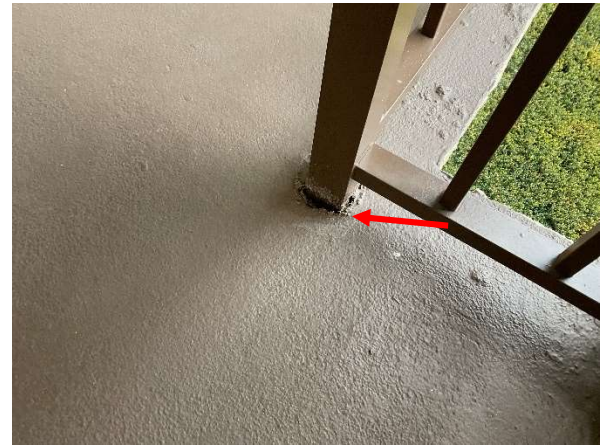
- 2.1.2 BECI also observed isolated areas of railing post bases not sealed to the concrete slabs. Additionally, BECI observed spalled and cracking at the common walkway concrete slabs of Buildings Alhambra, Barcelona, & Cadiz. These conditions can create a path for water intrusion and corrosion of the embedded steel, which compromises the structural integrity and can lead to further deterioration if not addressed promptly. **BECI recommends that the affected areas be repaired in the next year by a licensed Florida contractor** (Reference Photo Exhibit Nos. 10 through 18).

**Photo 10**  
 Building Cadiz – 3rd Floor – Overall view of railing post base not sealed to the concrete.

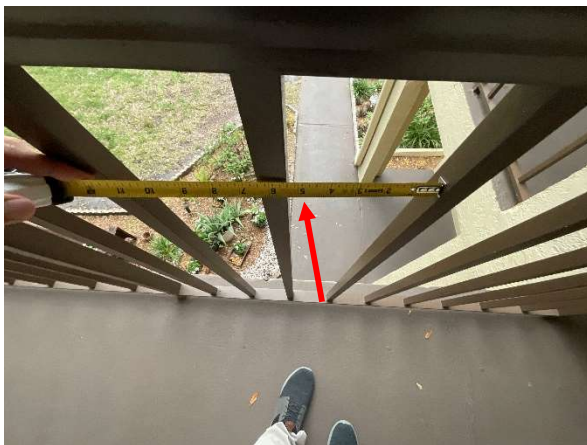
**Photo 8**  
 Building Barcelona – 2nd Floor – Overall view of spacing between guardrail pickets greater than 4”.

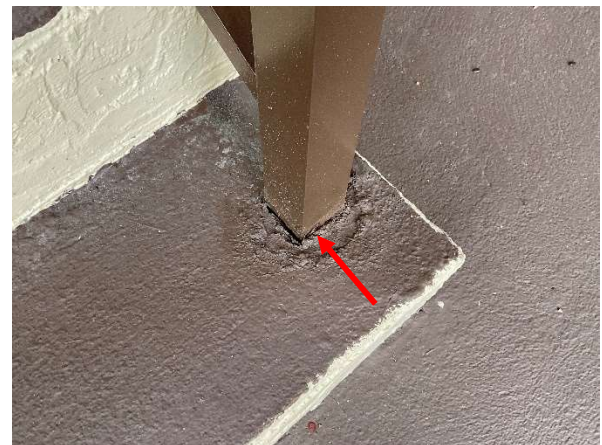
**Photo 11**  
 Building Cadiz – 1st Floor – Overall view of railing post base not sealed to the concrete.

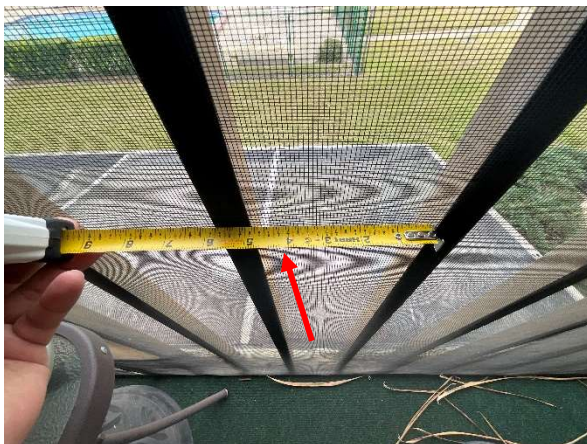
**Photo 9**  
 Building Alhambra – Unit No. 205 – Overall view of spacing between guardrail pickets greater than 4”.

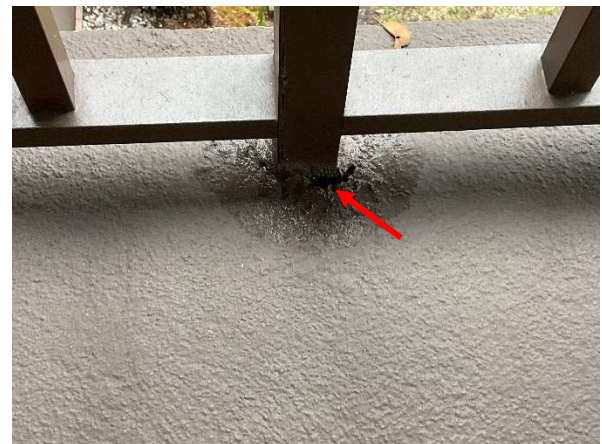
**Photo 12**  
 Building Barcelona – 3rd Floor – Overall view of railing post base not sealed to the concrete.

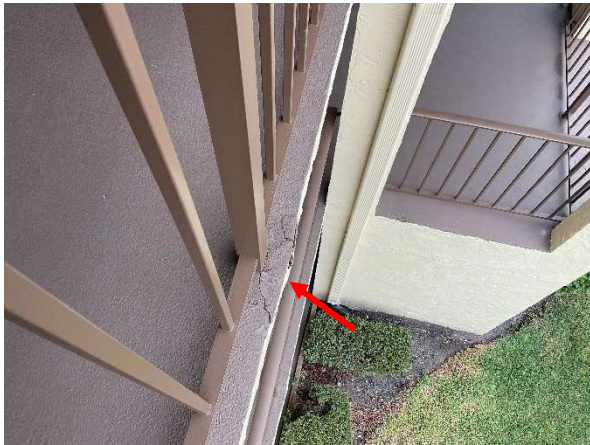
**Photo 13**  
 Building Alhambra – 3rd Floor - Overall view of spalling in the concrete slab.

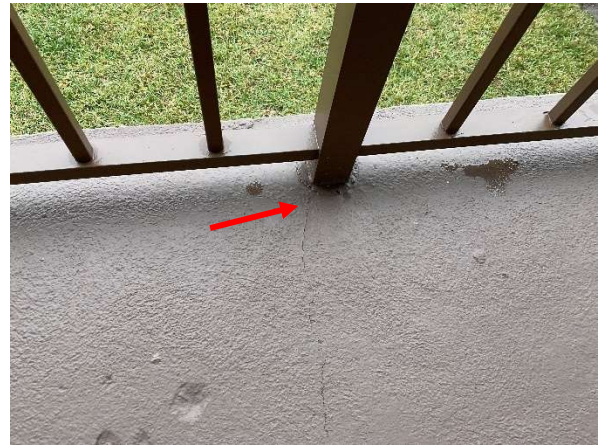
**Photo 16**  
 Building Cadiz – 2<sup>nd</sup> Floor - Overall view of cracking in the concrete slab.

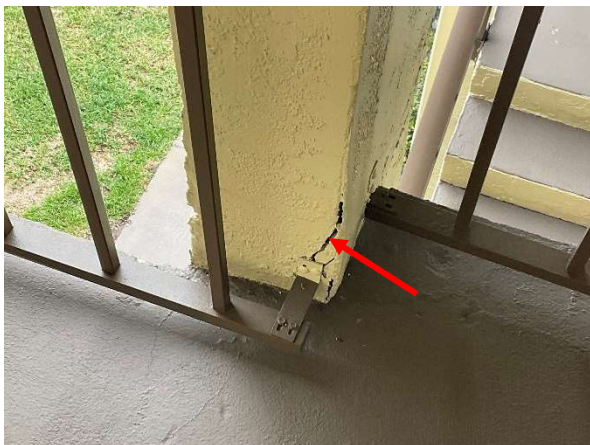
**Photo 14**  
 Building Alhambra – 3rd Floor - Overall view of spalling in the stucco cladding.

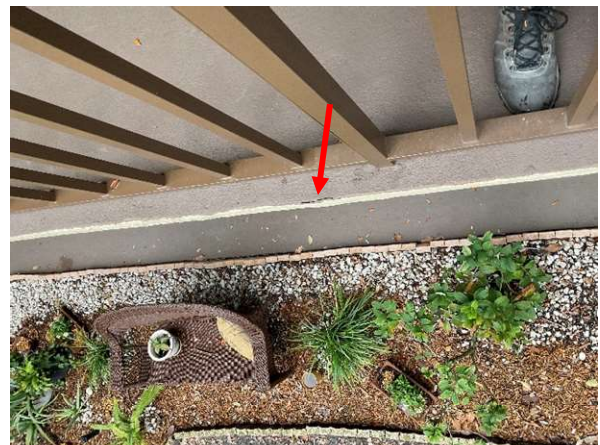
**Photo 17**  
 Building Barcelona – 2<sup>nd</sup> Floor - Overall view of spalling in the concrete slab.

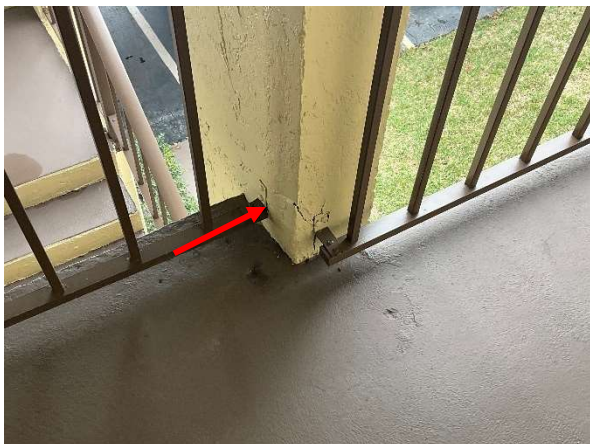
**Photo 155**  
 Building Alhambra – 3rd Floor - Overall view of spalling in the stucco cladding.

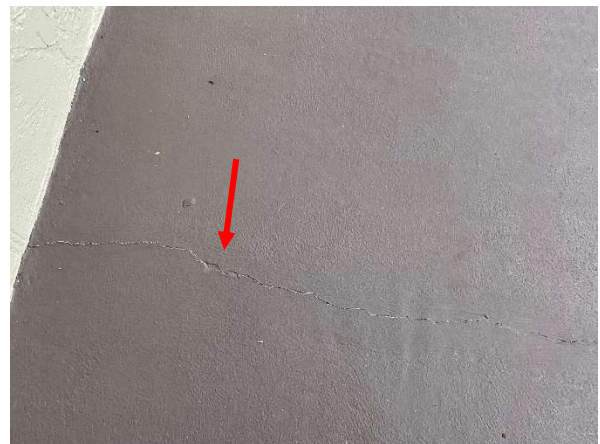
**Photo 18**  
 Building Alhambra – 2<sup>nd</sup> Floor - Overall view of cracking in the concrete slab.

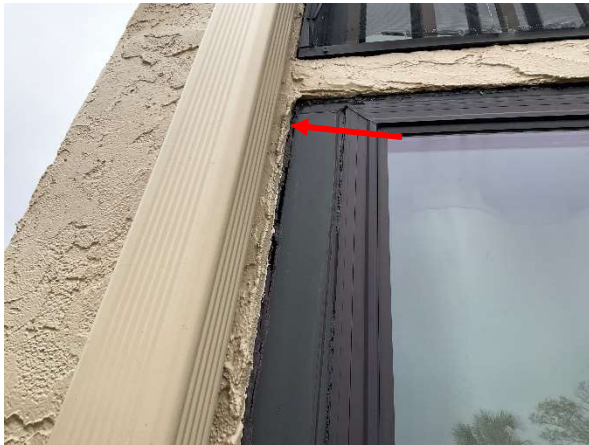
- 2.1.3 BECI also observed isolated areas of discontinuous sealant joints and voids at the perimeter of doors and windows, dissimilar substrate interfaces and wall penetrations on Buildings Alhambra, Barcelona, & Cadiz. The gaps in the sealant joints can allow for moisture intrusion, which may lead to deterioration of the building materials. Proper sealing is crucial to maintain the integrity of the waterproofing system. **BECI recommends that all discontinuous and missing sealant joints be addressed within the next year by a licensed Florida contractor** (Reference Photo Exhibit Nos. 19 through 24).

**Photo 19**  
 Building Cadiz – 1<sup>st</sup> Floor - Overall view of deterioration and voids in the sealant joint.

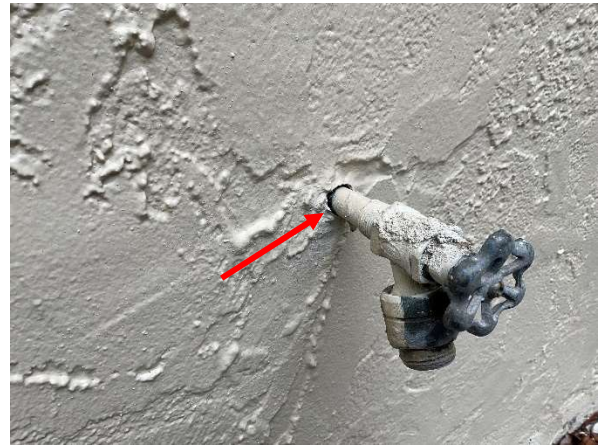
**Photo 22**  
 Building Cadiz – 1<sup>st</sup> Floor - Overall view of wall penetration not sealed.

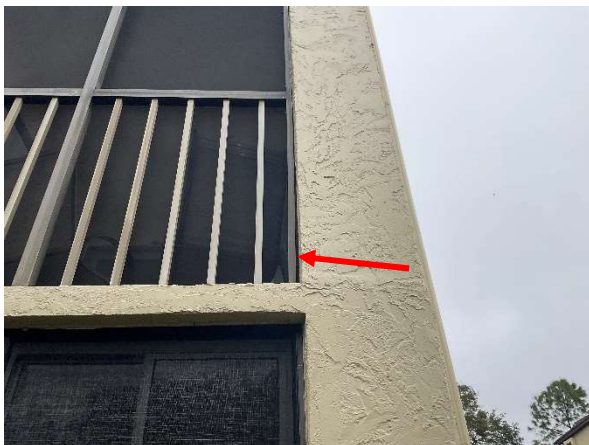
**Photo 20**  
 Building Barcelona – 2nd Floor - Overall view of missing sealant at dissimilar material interfaces.

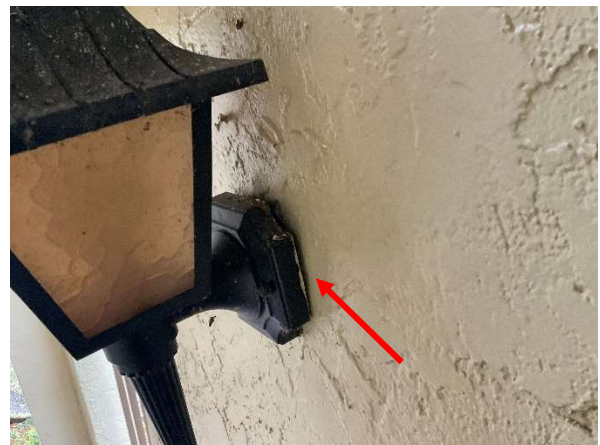
**Photo 23**  
 Building Barcelona – 3rd Floor - Overall view of wall penetration not sealed.

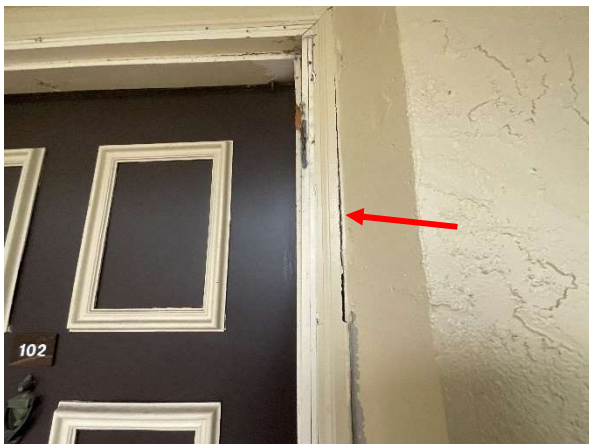
**Photo 21**  
 Building Barcelona – Unit No. 102 - Overall view of missing sealant at dissimilar material interfaces.

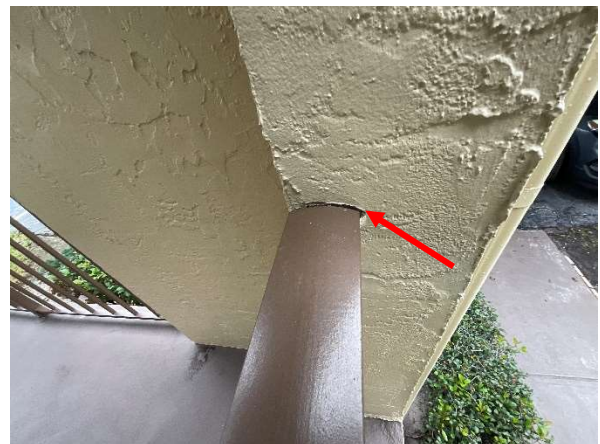
**Photo 24**  
 Building Alhambra – 2nd Floor – Overall view of missing sealant at dissimilar material interfaces.

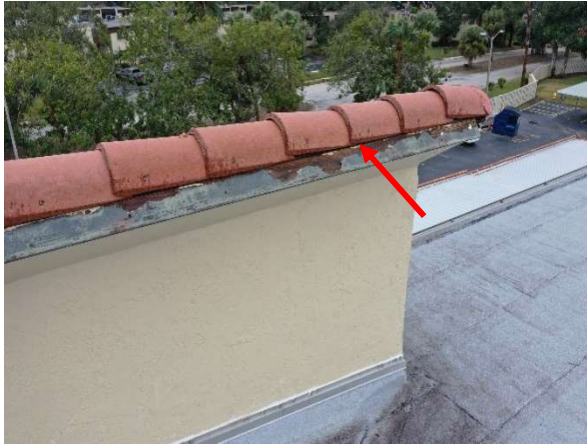
- 2.1.4 Furthermore, BECI observed isolated areas of delaminated and deteriorated wood fascias on Buildings Alhambra, Barcelona, & Cadiz. Delamination of the exterior coatings is typically indicative of moisture intrusion in the surrounding areas. BECI also observed an isolated wall missing exterior coating on the roof of Building Cadiz. Deteriorated exterior coatings can allow for moisture intrusion, causing microbial growth and deterioration of underlying materials. **BECI recommends that the areas of deteriorated and delaminated exterior coatings be removed, and new coatings reinstalled within the next year by a licensed Florida contractor** (Reference Photo Exhibit Nos. 25 through 29).

**Photo 25**  
 Building Alhambra – Roof - Overall view of coating delamination of the wood fascia.

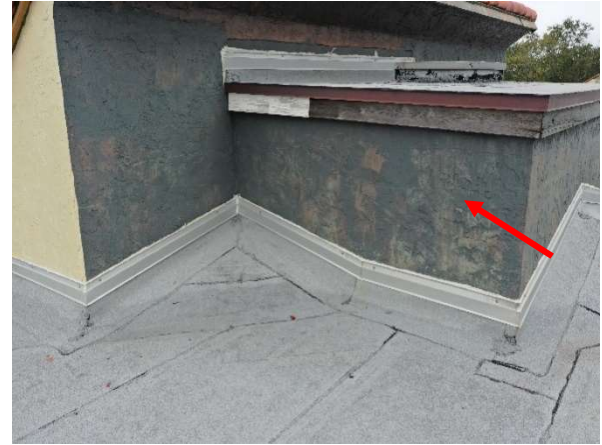
**Photo 28**  
 Building Cadiz – Roof – Overall view of exterior wall missing coating.

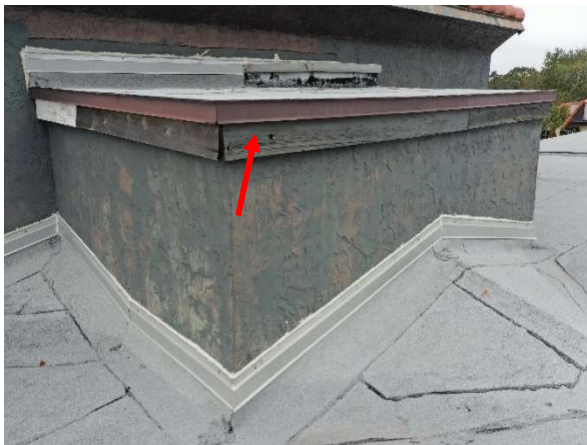
**Photo 26**  
 Building Cadiz – Roof - Overall view of deterioration of the wood fascia.

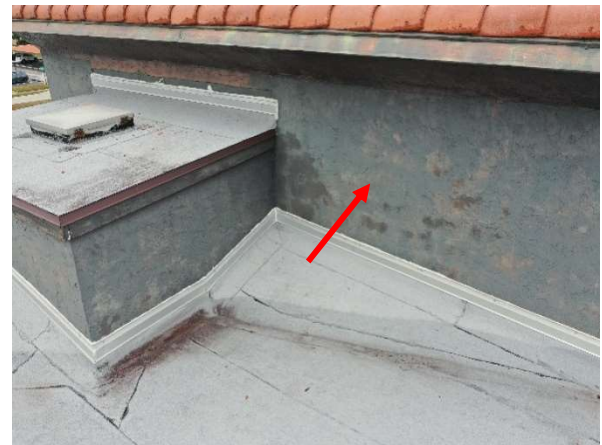
**Photo 29**  
 Building Cadiz – Roof – Overall view of exterior wall missing coating.

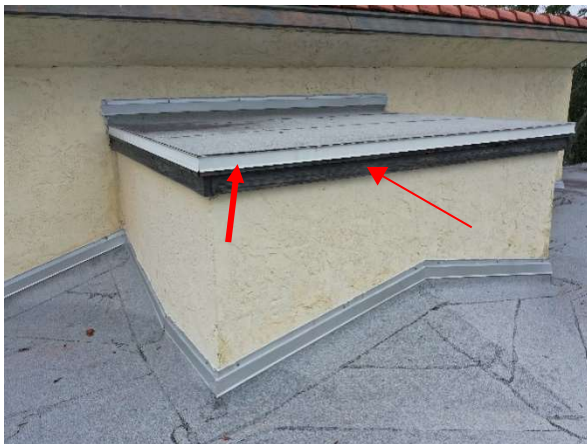
**Photo 27**  
 Building Barcelona – Roof - Overall view of deterioration of the wood fascia.
