COMMERCIAL WINDSTORM MITIGATION REPORT (OIR-B1-1802)

Casa Del Sol Association, Inc.

2420 Winding Creek Blvd, Units 101-108, 201-208

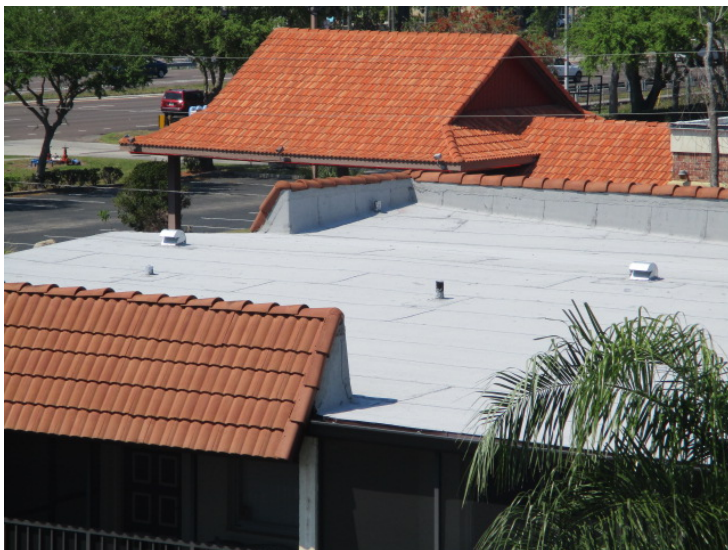
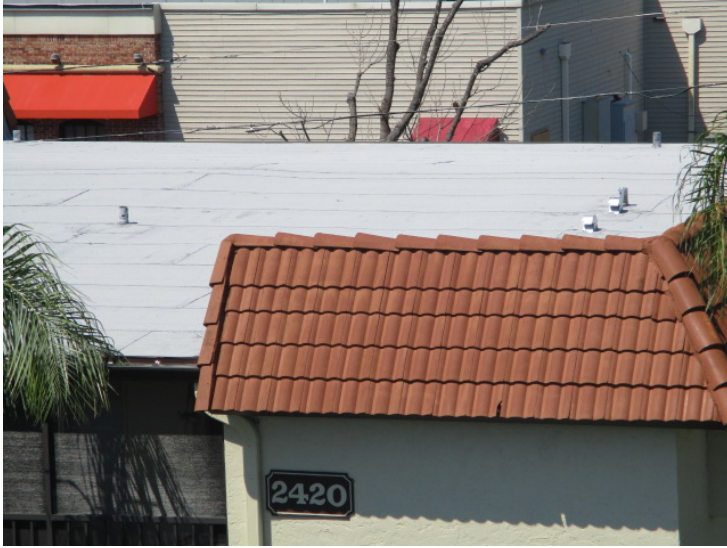
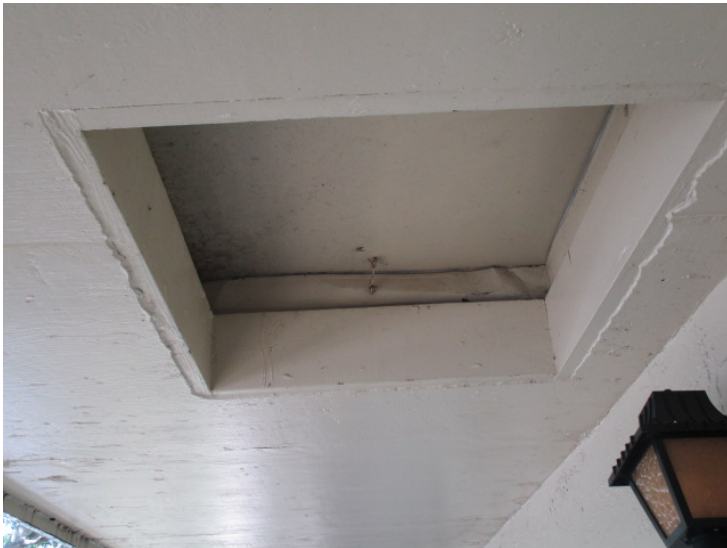
Roof Construction

Comments: | Reinforced Concrete Roof Deck
Inspection verified a roof structure composed of cast-in-place or pre-cast structural concrete designed to be self-supporting and integrally attached to the wall / support system. |

Comments: | Structural
Inspection verified a roof structure composed of cast-in-place or pre-cast structural concrete designed to be self-supporting and integrally attached to the wall / support system. |

Comments: | Flat Roof
Inspection verified flat roof shape, refer to attached photographs. |
