COMMERCIAL WINDSTORM MITIGATION REPORT (OIR-B1-1802)

Casa Del Sol Association, Inc.

2420 Winding Creek Blvd, Units 109-112, 209-212

As of 3/21/2019
FPAT File# MIT1913224

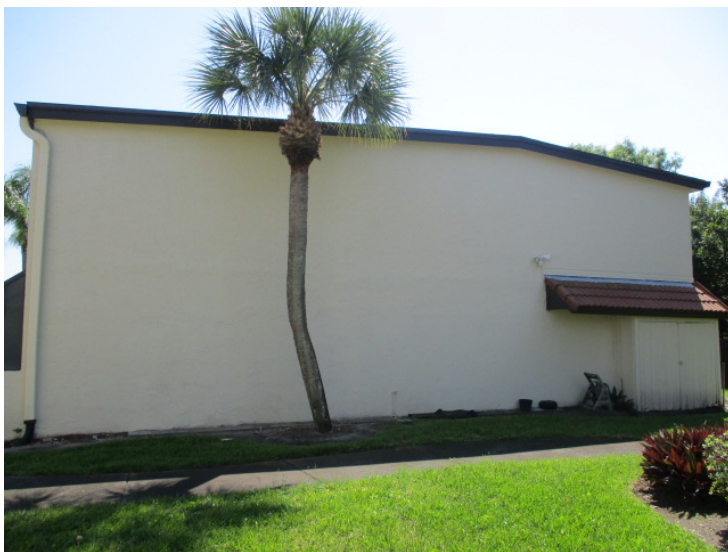
Exterior Elevation

Comments: | Flat Roof
Inspection verified flat roof shape, refer to attached photographs. |

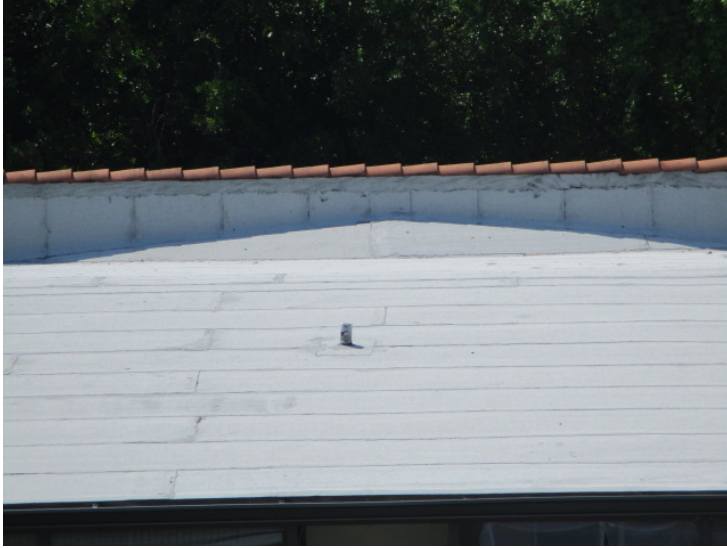
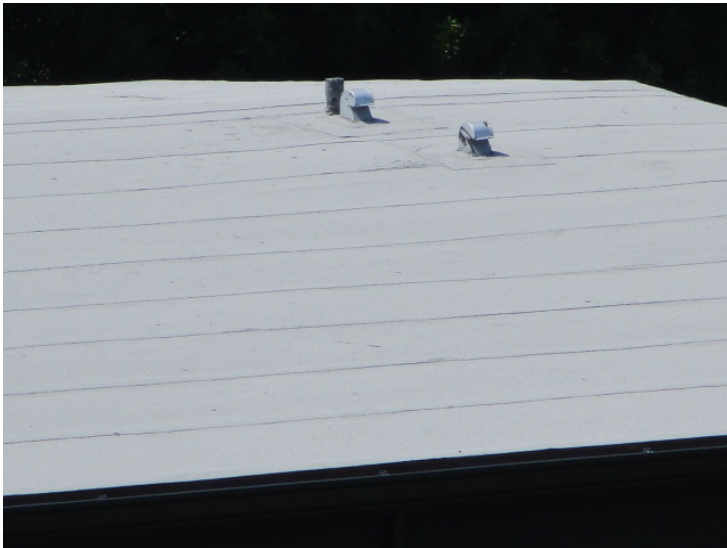
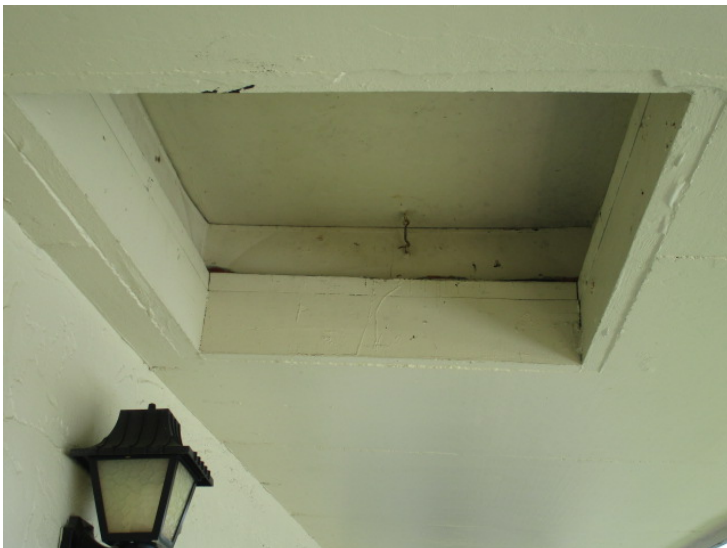
Roof Construction

Comments: | Reinforced Concrete Roof Deck
Inspection verified a roof structure composed of cast-in-place or pre-cast structural concrete designed to be self-supporting and integrally attached to the wall / support system. |

Comments: | Structural
Inspection verified a roof structure composed of cast-in-place or pre-cast structural concrete designed to be self-supporting and integrally attached to the wall / support system. |

Comments: | No
SWR does not apply to reinforced concrete roof decks. |
