COMMERCIAL WINDSTORM MITIGATION REPORT (OIR-B1-1802)

Casa Del Sol Association, Inc.
2440 Winding Creek Blvd, Units 101-308
Clearwater, FL 33761

As of 3/21/2019
FPAT File# MIT1913224

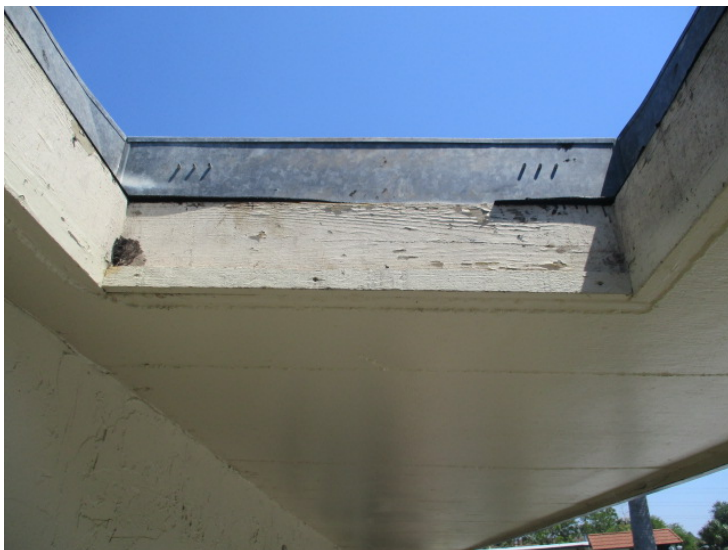
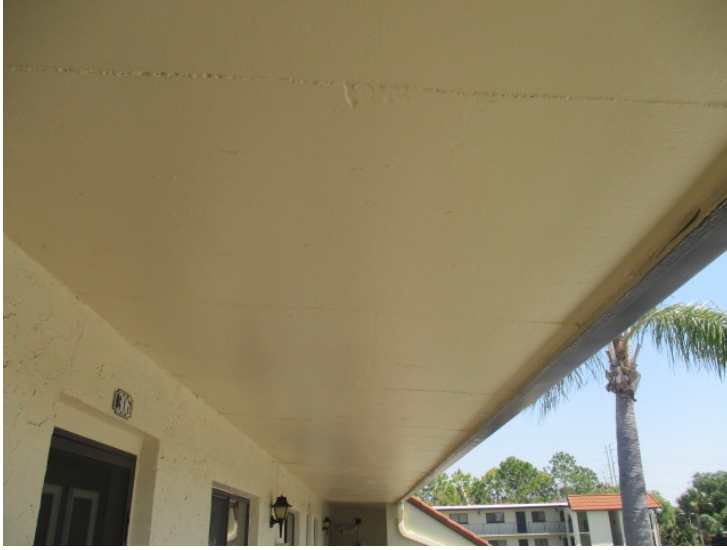
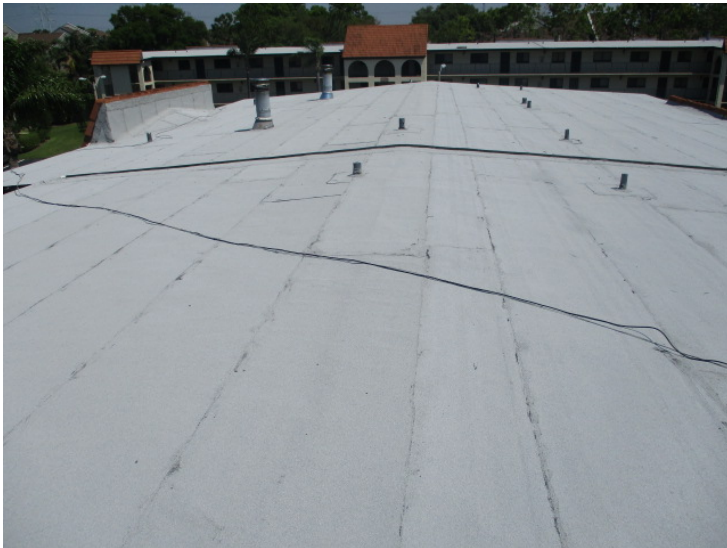
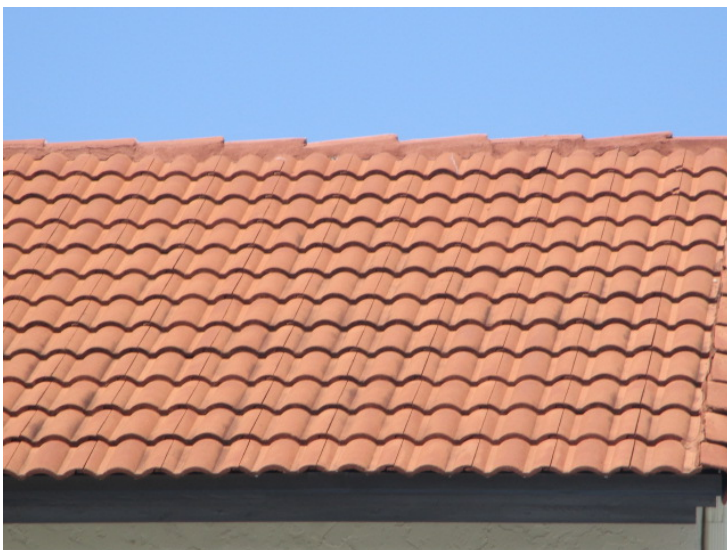
Roof Construction

- 3. Roof Deck Attachment:** **Reinforced Concrete Roof Deck**
Comments: Inspection verified a roof structure composed of cast-in-place or pre-cast structural concrete designed to be self-supporting and integrally attached to the wall / support system.

- 4. Roof to Wall Attachment:** **Structural**
Comments: Inspection verified a roof structure composed of cast-in-place or pre-cast structural concrete designed to be self-supporting and integrally attached to the wall / support system.

- 5. Roof Geometry:** **Flat Roof**
Comments: Inspection verified flat roof shape, refer to attached photographs.
- 6. SWR:** **No**
Comments: SWR does not apply to reinforced concrete roof decks.
