COMMERCIAL WINDSTORM MITIGATION REPORT (OIR-B1-1802)

Casa Del Sol Association, Inc.
3055 Casa Del Sol Cir, Units 101-309
Clearwater, FL 33761

As of 3/21/2019
FPAT File# MIT1913224

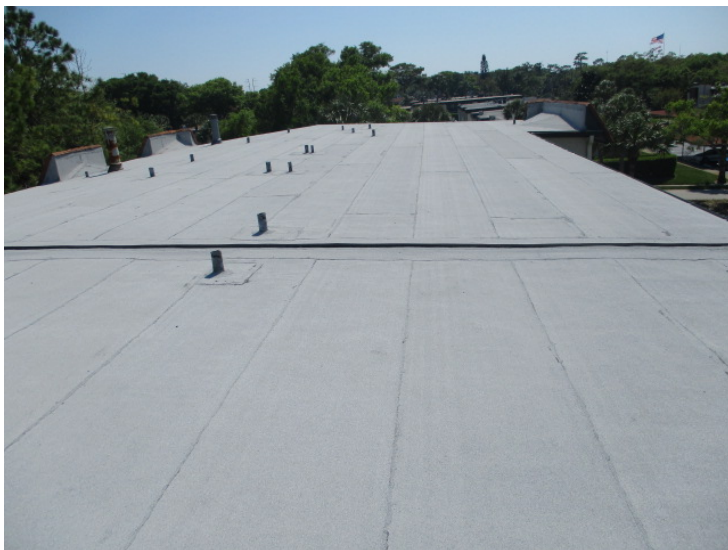
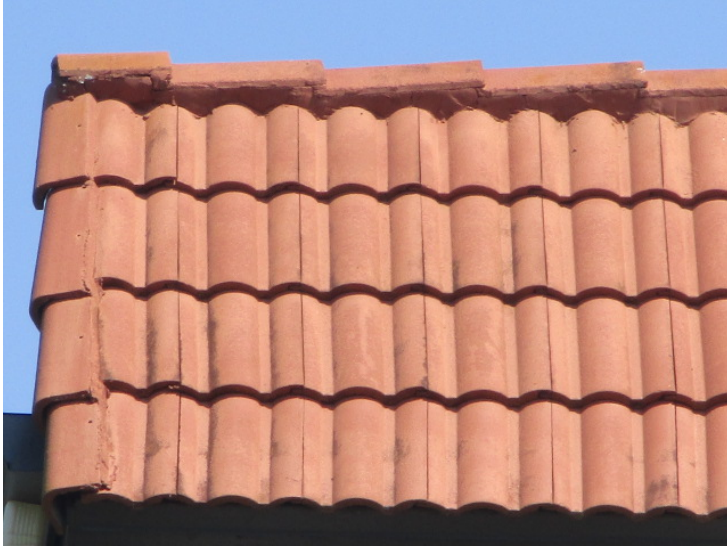
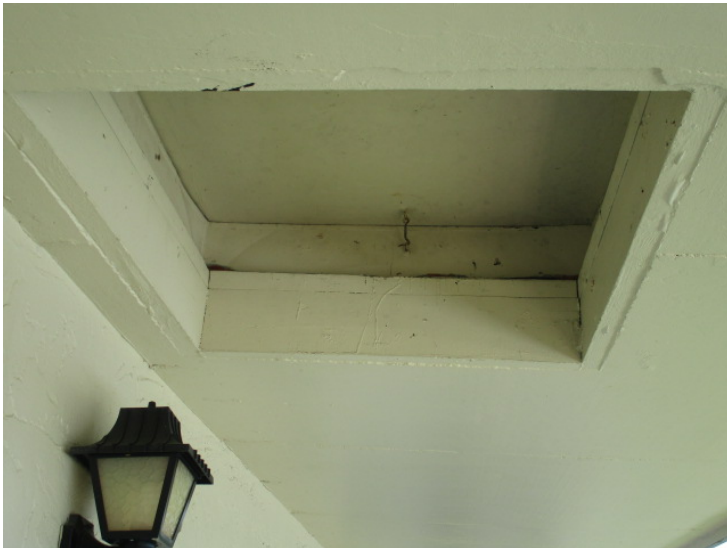
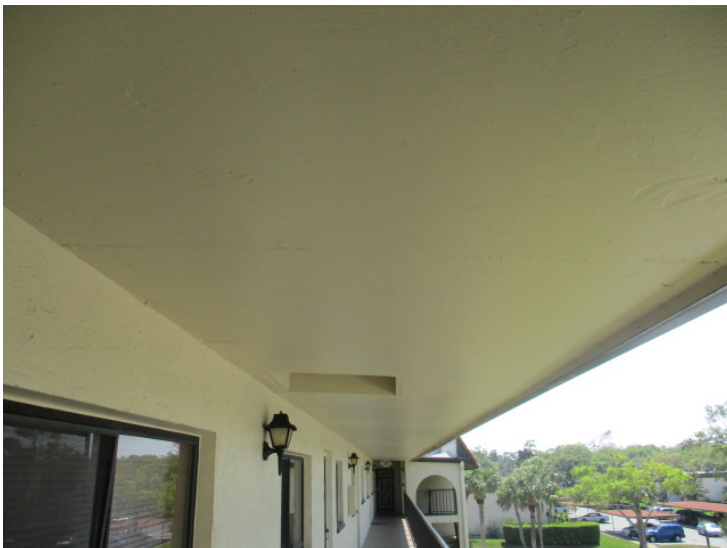
Roof Construction

- 3. Roof Deck Attachment:** **Reinforced Concrete Roof Deck**
Comments: Inspection verified a roof structure composed of cast-in-place or pre-cast structural concrete designed to be self-supporting and integrally attached to the wall / support system.

- 4. Roof to Wall Attachment:** **Structural**
Comments: Inspection verified a roof structure composed of cast-in-place or pre-cast structural concrete designed to be self-supporting and integrally attached to the wall / support system.

- 5. Roof Geometry:** **Flat Roof**
Comments: Inspection verified flat roof shape, refer to attached photographs.
- 6. SWR:** **No**
Comments: SWR does not apply to reinforced concrete roof decks.
