## COMMERCIAL WINDSTORM MITIGATION REPORT (OIR-B1-1802)

Casa Del Sol Association, Inc.  
3077 Casa Del Sol Cir, Units 101-309  
Clearwater, FL 33761

As of 3/21/2019  
FPAT File# MIT1913224

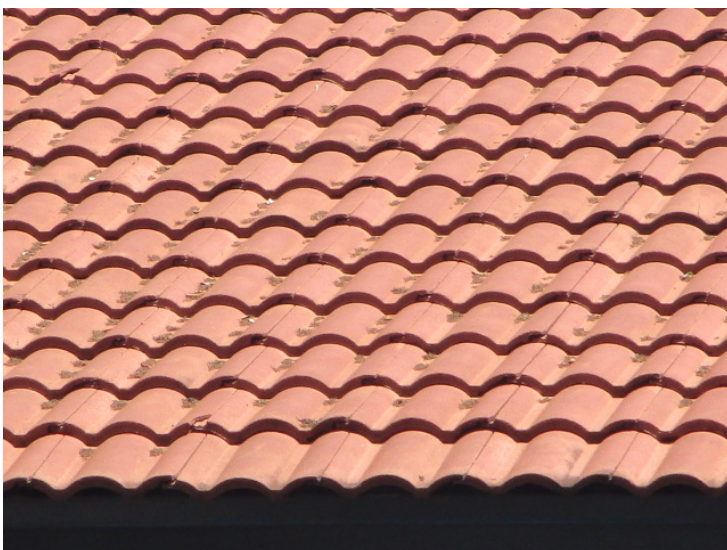
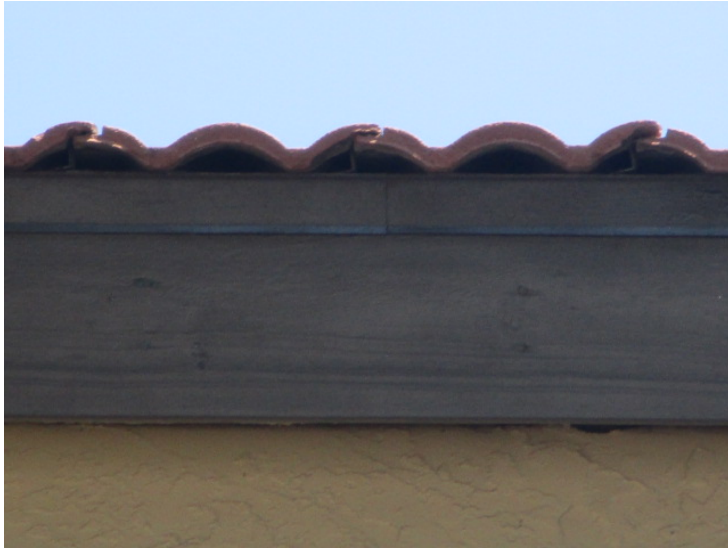
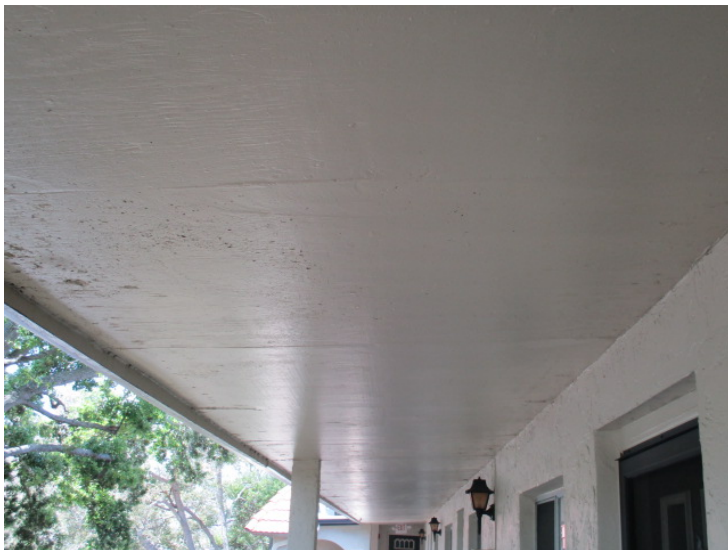
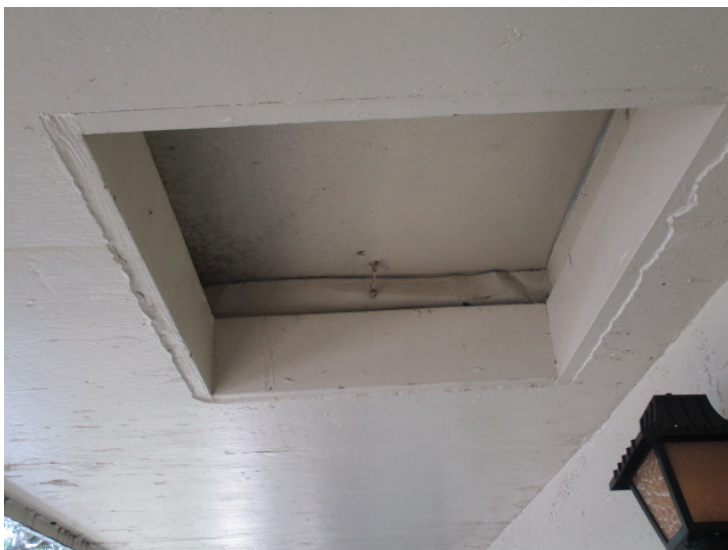
Roof Construction

| <b>3. <u>Roof Deck Attachment:</u></b><br>Comments: | <b>Reinforced Concrete Roof Deck</b><br>Inspection verified a roof structure composed of cast-in-place or pre-cast structural concrete designed to be self-supporting and integrally attached to the wall / support system. |
| <b>4. <u>Roof to Wall Attachment:</u></b><br>Comments: | <b>Structural</b><br>Inspection verified a roof structure composed of cast-in-place or pre-cast structural concrete designed to be self-supporting and integrally attached to the wall / support system. |
| <b>5. <u>Roof Geometry:</u></b><br>Comments: | <b>Flat Roof</b><br>Inspection verified flat roof shape, refer to attached photographs. |
