February 14, 2025

Casa Del Sol Condominium Barcelona Owners Association
3055 Casa Del Sol Circle
Clearwater, Florida 33761

Regarding: **2025 Structural Integrity Reserve Study
(Barcelona)**

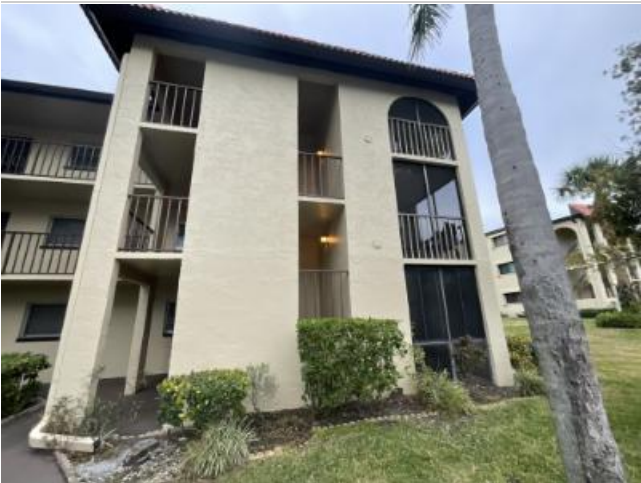
1 - Exterior Walls Paint - (Barcelona)

- **Exterior Walls** – This category contains exterior wall paint, repairs to the wall system, and partial sealant removal and replacement at the perimeters of window openings, door openings, expansion joints, and wall penetrations. The wall cladding on the building was observed to be in “good-to-fair” condition.

Type of Cost:	Replacement
Location:	Waterproofing
Category:	
Condition:	Good

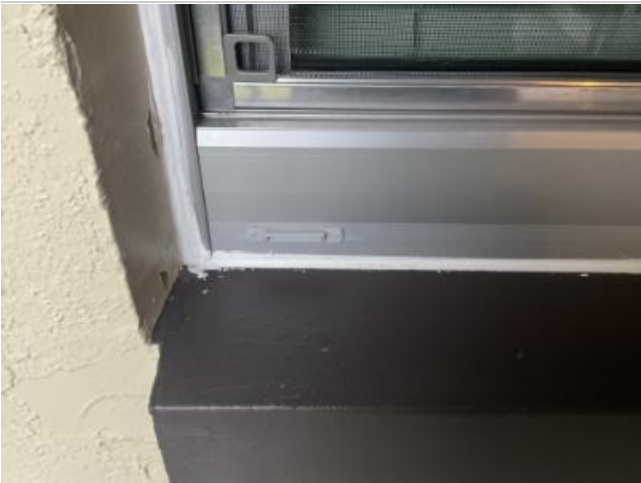
2 - Sealants - (Barcelona)

Type of Cost:	Replacement
Location:	Waterproofing
Category:	
Condition:	Fair

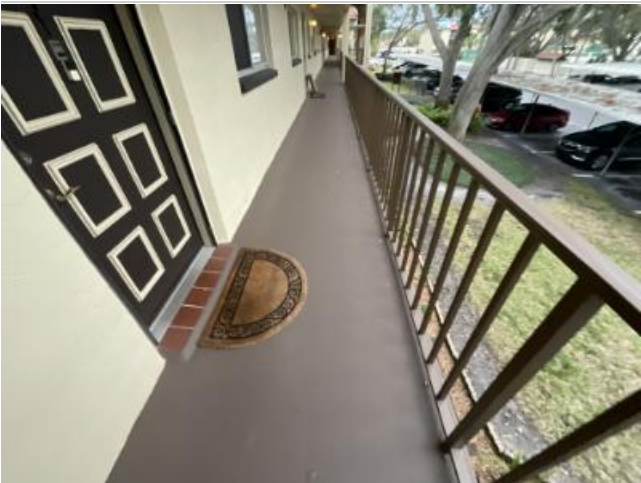
3 - Common Walkway Deck - (Barcelona)

- **Deck Waterproofing** – The deck waterproofing portion of the structural integrity reserve study includes the deck coating on the common walkways and private balconies. The deck waterproofing on the building was observed to be in “good-to-fair” condition at the time of our site visit.

Type of Cost:	Replacement
Location:	Waterproofing
Category:	
Condition:	Good to Fair

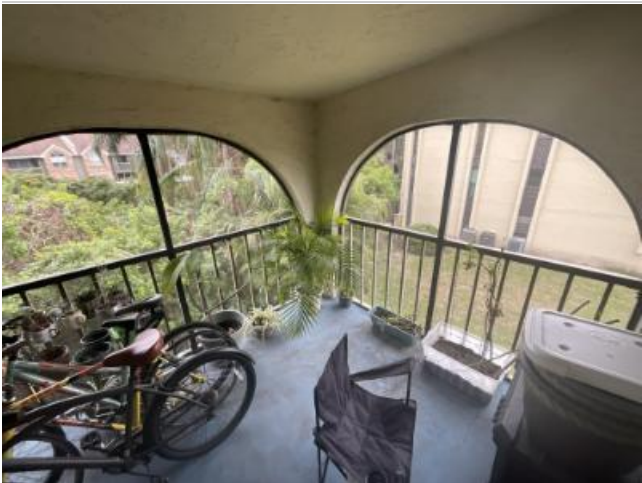
4 - Private Balcony Deck Coating - (Barcelona)

Type of Cost:	Replacement
Location:	Waterproofing
Category:	
Condition:	Fair

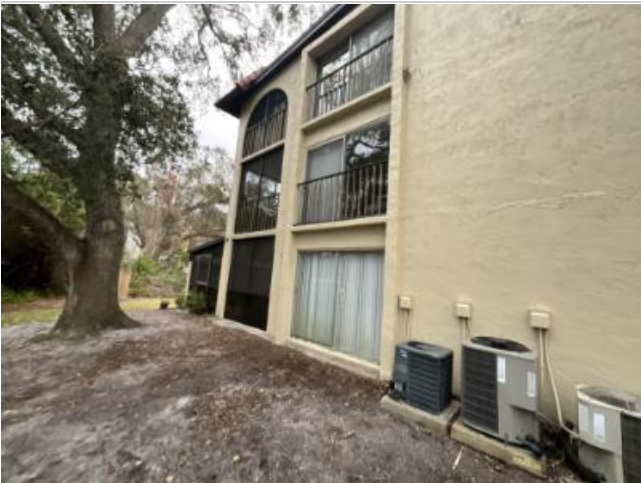
5 - Load Bearing Walls/Primary Structural Members - (Barcelona)

- **Structural** – The structural portion of the structural integrity reserve study includes the load-bearing walls, and other primary structural members. The structural components of the building were observed to be in “good” condition at the time of our site visit.

Type of Cost:	Repairs & Maintenance
Location:	Structural
Category:	
Condition:	Good

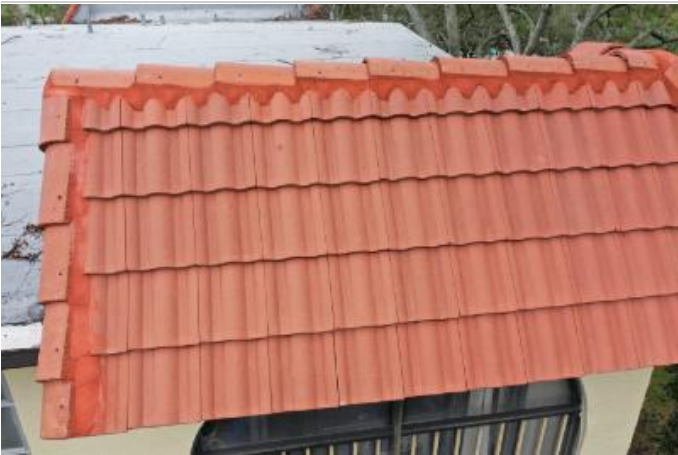
6 - Tile Roof - (Barcelona)

- **Roofing** – Funding for this category is for the replacement and repairs of the roofing systems. BE-CI observed the roofing systems were considered to be in “good-to-fair” condition at the time of our site visit.

Type of Cost:	Replacement
Location:	Roofing
Category:	
Condition:	Good

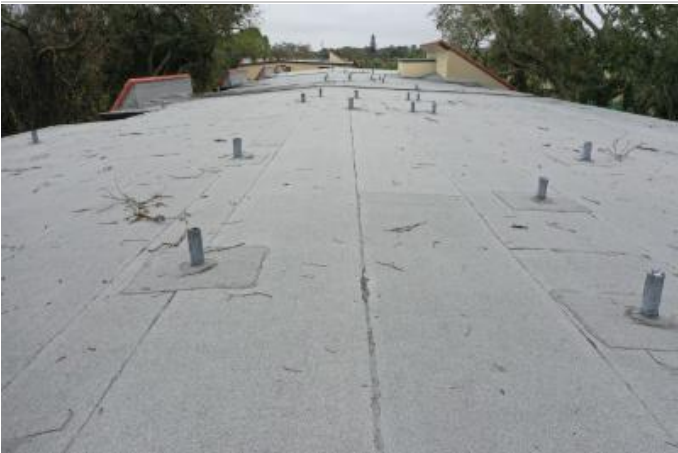
7 - Mod-bit Roof - (Barcelona)

Type of Cost:	Replacement
Location:	Roofing
Category:	
Condition:	Good to Fair

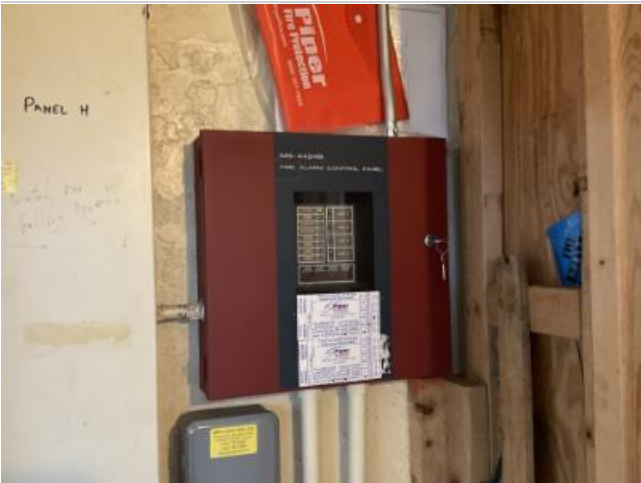
8 - Fire Controls Modernization - (Barcelona)

- **Fire Control System and Modernization** – The Fire Control Systems portion of the structural integrity reserve study includes the fire alarm system, fire detection devices and fire panels. The fire control system was observed to be in “good” condition at the time of our site visit.

Type of Cost:	Replacement
Location:	Fire Protection
Category:	
Condition:	Good
