Windstorm Mitigation Report

Casa Del Sol Association

Clearwater, FL

As of 10-14-2024 | FPAT File# MUD2423385

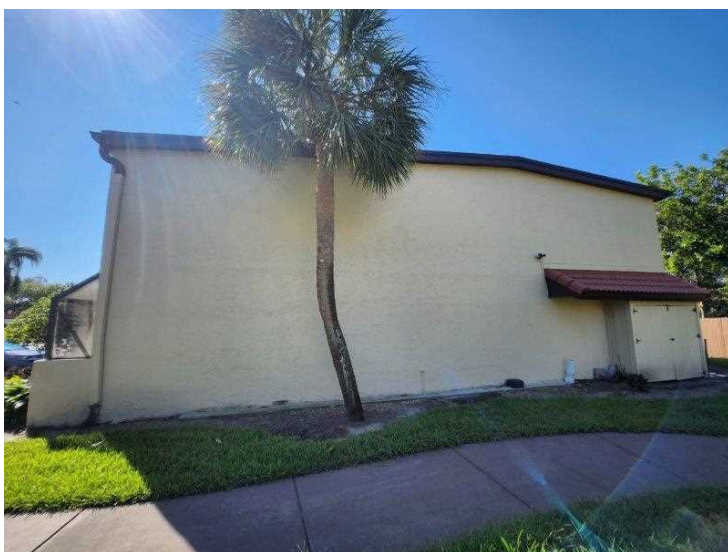
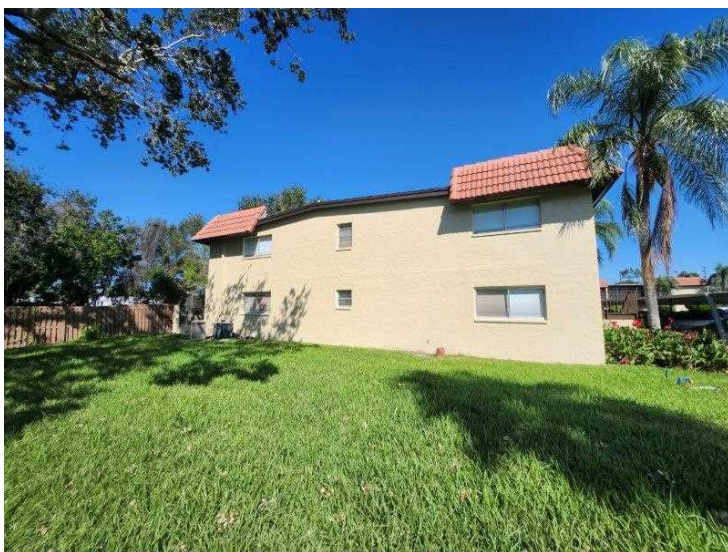
Exterior Elevation

- 5. Roof Geometry:** **Flat Roof**
Comments: Inspection verified flat roof shape, refer to attached photographs.
- 6. SWR:** **No**
Comments: SWR does not apply to reinforced concrete roof decks.

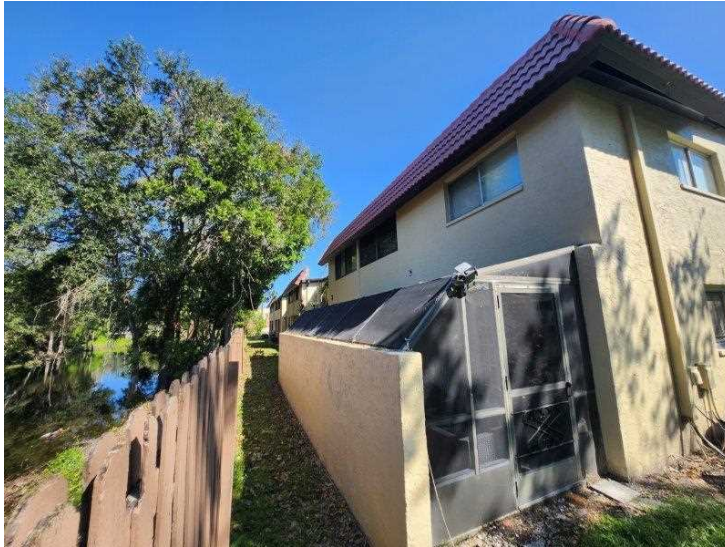
Roof Permit Information

- 2. Roof Covering:** **FBC Equivalent**
Comments: The flat roof covering was replaced in 2018. The roof permit was confirmed and the permit number is CW18-15080. The pitched roof covering was replaced in 2023. The roof permit was confirmed and the permit number is EBP-23-19119. This roof was verified as meeting the building code requirements outlined on the mitigation affidavit.

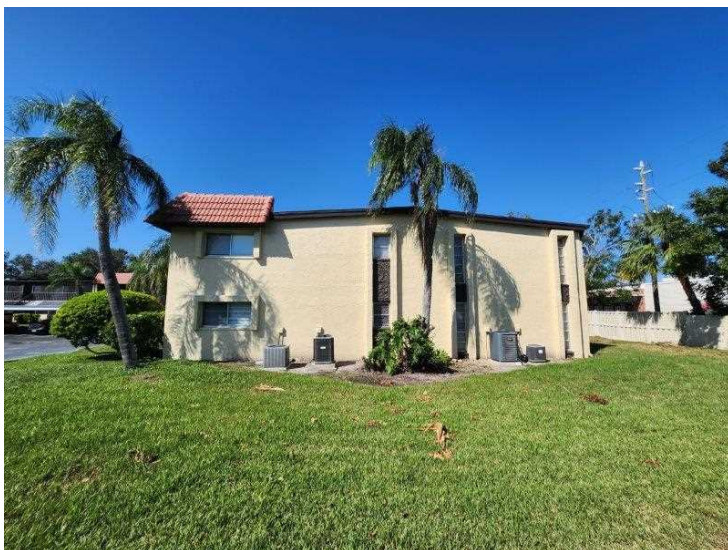
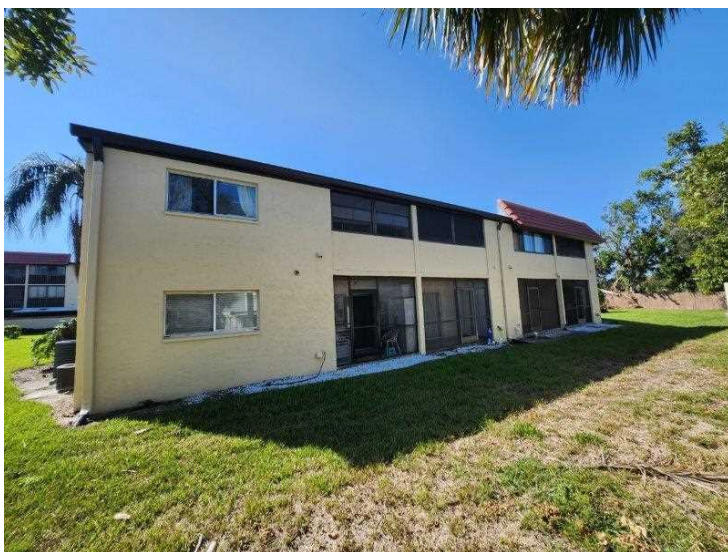
Exterior Elevation

- 5. Roof Geometry:** **Flat Roof**
Comments: Inspection verified flat roof shape, refer to attached photographs.
- 6. SWR:** **No**
Comments: SWR does not apply to reinforced concrete roof decks.

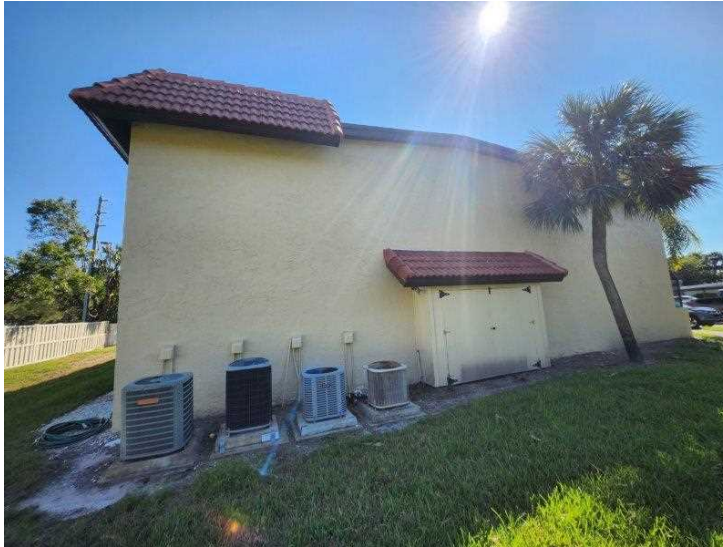
Roof Permit Information

- 2. Roof Covering:** **FBC Equivalent**
Comments: The flat roof covering was replaced in 2018. The roof permit was confirmed and the permit number is CW18-15077. The pitched roof covering was replaced in 2023. The roof permit was confirmed and the permit number is EBP-23-19119. This roof was verified as meeting the building code requirements outlined on the mitigation affidavit.

Detail	
Inspections	Status
Case / Application / Permit Number Type / Classification	CW18-15077 COMBOWEB RFCFLT: Roofing - Commercial Flat BLDG: Building Department 2420 WINDING CREEK CIR Pinellas County, FL
Address	2420 WINDING CREEK CIR Pinellas County, FL
Parcel Number	192816140990000001
File Date	2018-11-01
Status	FINALED
Status Date	N/A
Valuation	\$25,000.00
Fees	\$166.75
Payments	\$166.75
Balance	\$0.00
Description	50 sq FL 2533.1 Flat

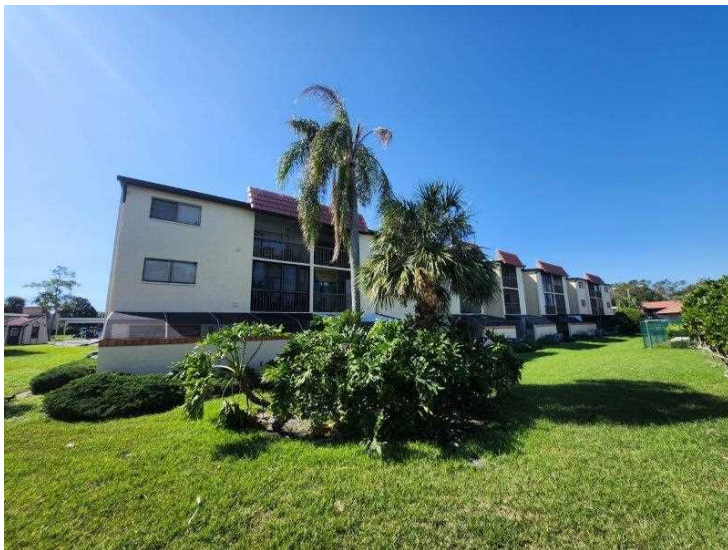
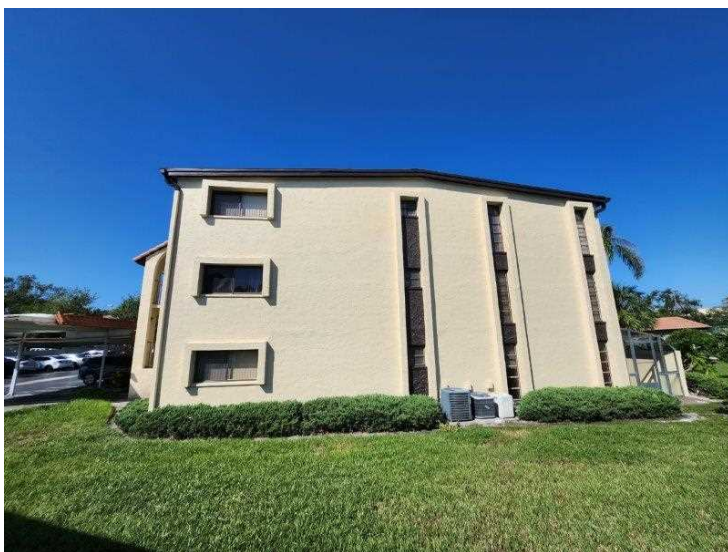
Exterior Elevation

- 5. Roof Geometry:** **Flat Roof**
Comments: Inspection verified flat roof shape, refer to attached photographs.
- 6. SWR:** **No**
Comments: SWR does not apply to reinforced concrete roof decks.

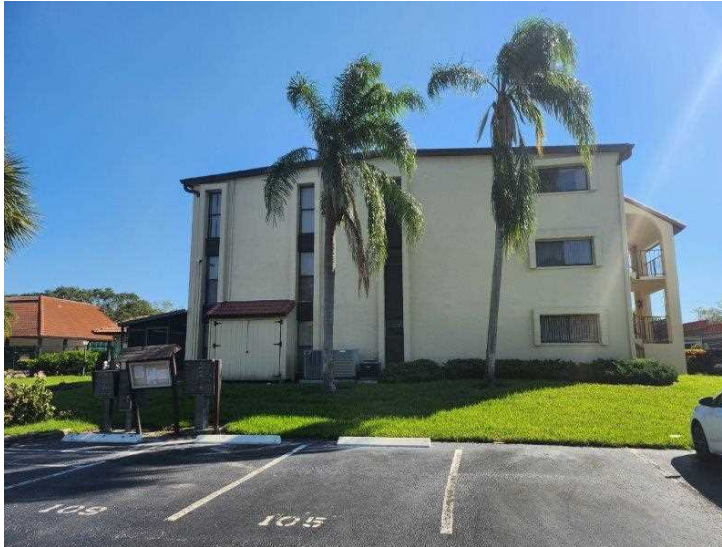
Roof Permit Information

- 2. Roof Covering:** **FBC Equivalent**
Comments: The flat roof covering was replaced in 2018. The roof permit was confirmed and the permit number is CW18-15073. The pitched roof covering was replaced in 2023. The roof permit was confirmed and the permit number is EBP-23-19120. This roof was verified as meeting the building code requirements outlined on the mitigation affidavit.

Case / Application / Permit Number Type / Classification	CW18-15073 COMBOWEB RFCFLT: Roofing - Commercial Flat BLDG: Building Department
Address	2440 WINDING CREEK BLVD Pinellas County, FL
Parcel Number	19281614063000001
File Date	2018-11-01
Status	FINALED
Status Date	N/A
Valuation	\$62,800.00
Fees	\$219.55
Payments	\$219.55
Balance	\$0.00
Description	FL 2533.1 Flat 123 sq

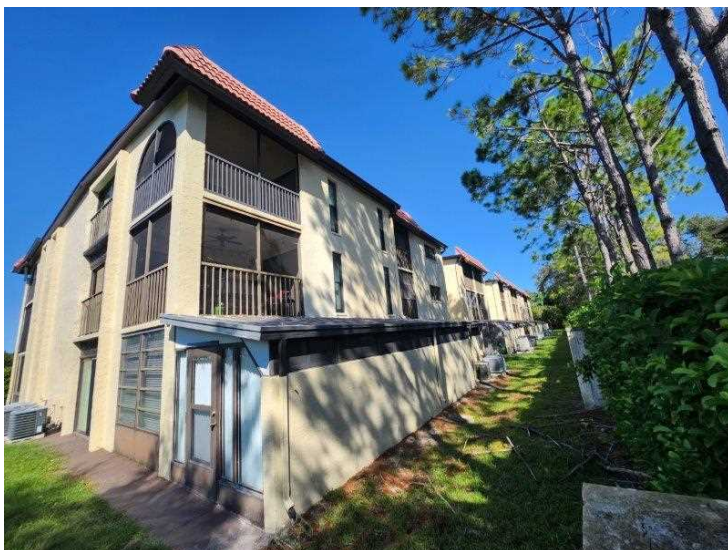
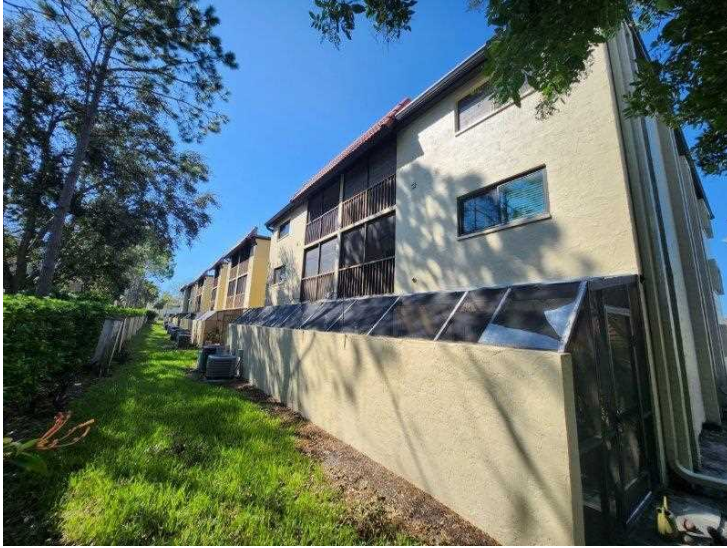
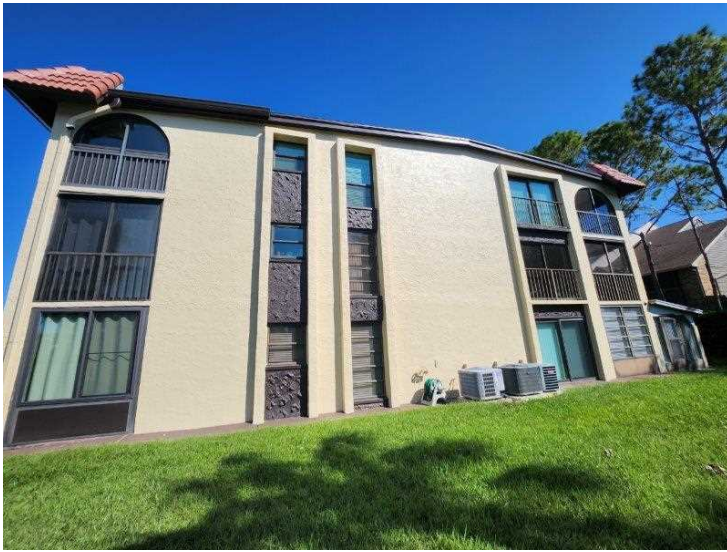
Exterior Elevation

- 5. Roof Geometry:** **Flat Roof**
Comments: Inspection verified flat roof shape, refer to attached photographs.
- 6. SWR:** **No**
Comments: SWR does not apply to reinforced concrete roof decks.

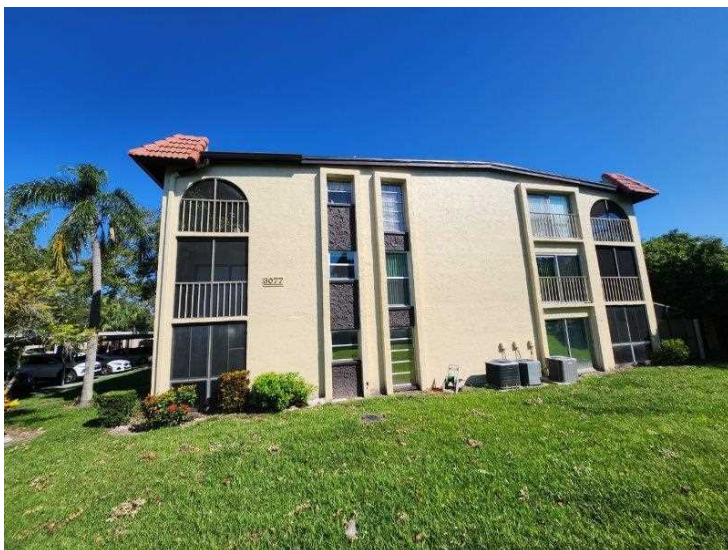
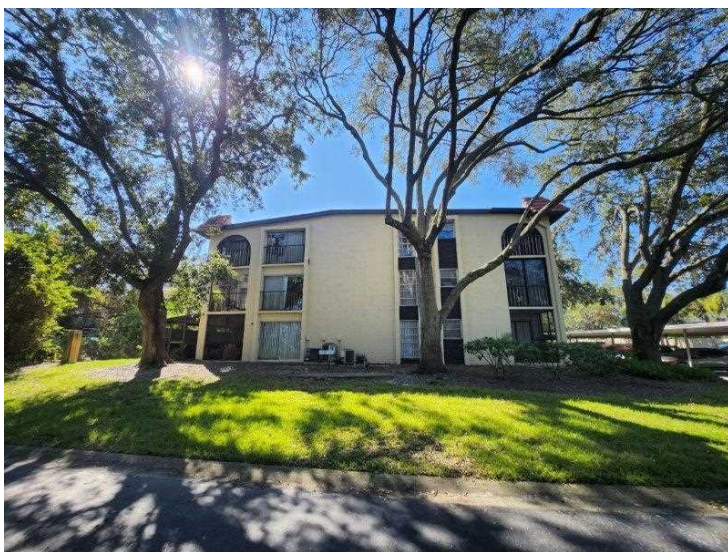
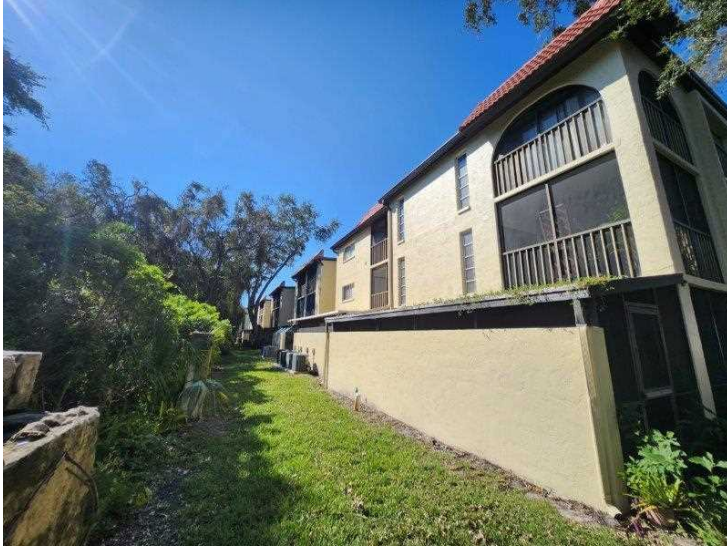
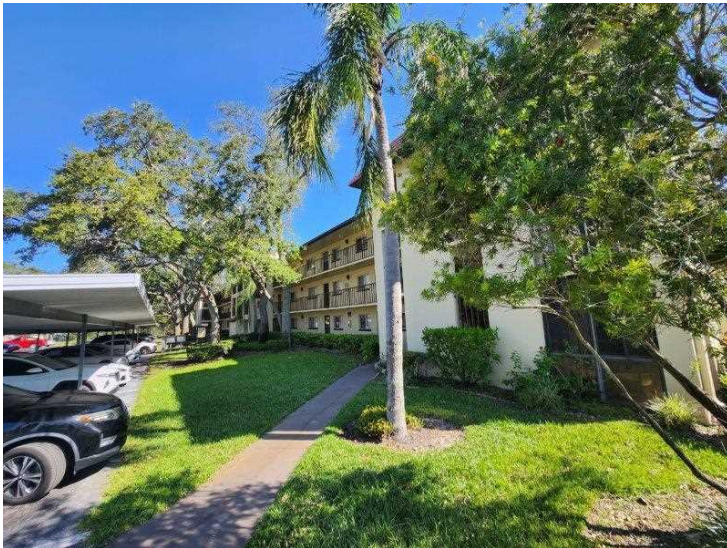
Exterior Elevation

- 5. Roof Geometry:** **Flat Roof**
Comments: Inspection verified flat roof shape, refer to attached photographs.
- 6. SWR:** **No**
Comments: SWR does not apply to reinforced concrete roof decks.

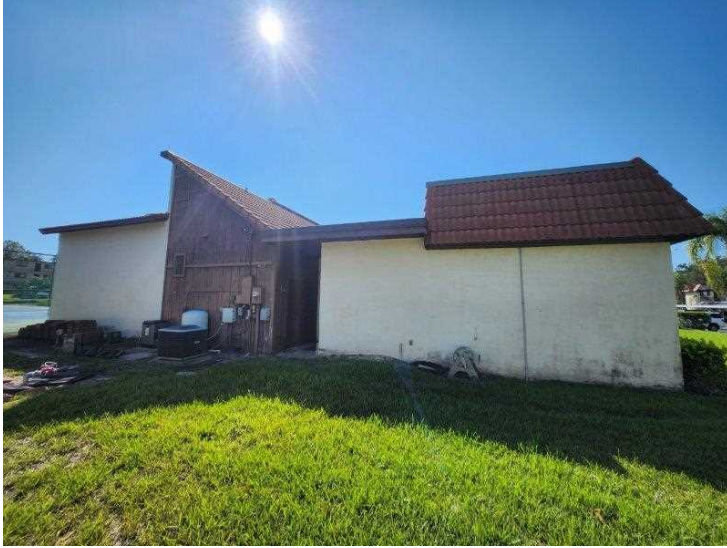
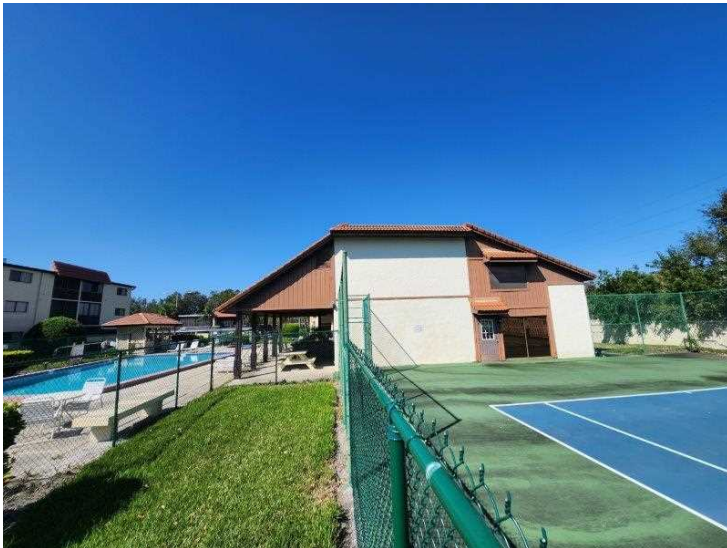
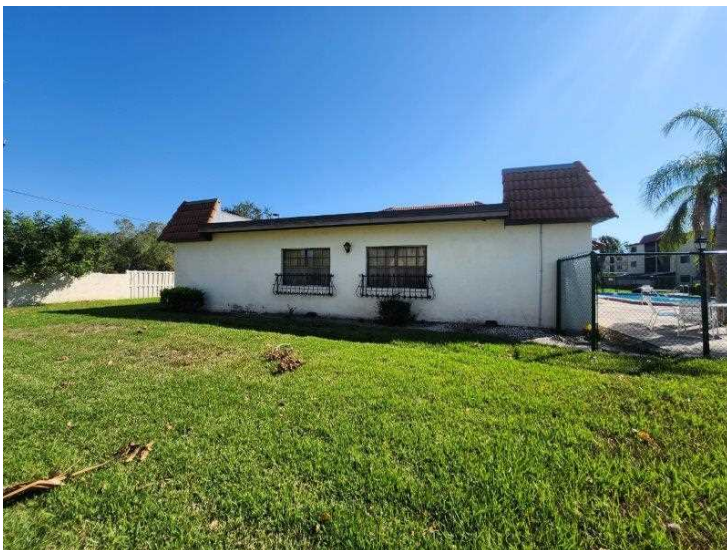
Exterior Elevation

- 4. Roof to Wall Attachment:** **Clips**
Comments: Inspection verified embedded straps fastened with a minimum of three nails.
- 5. Roof Geometry:** **Other Roof**
Comments: The roof shape is made up of a combination of flat and pitched sections. The flat area of the roof comprises approximately 42% of the total roof area.

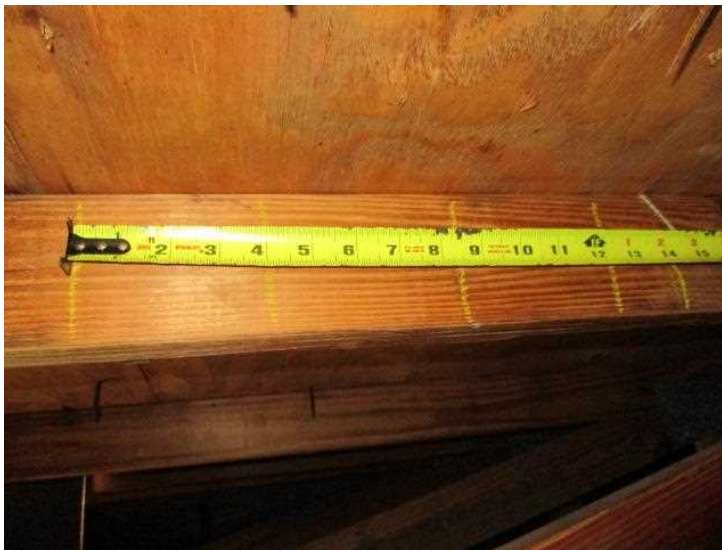
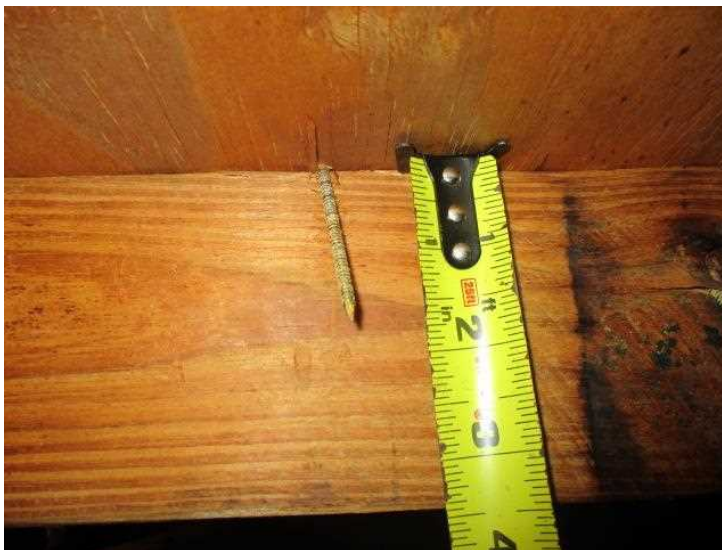
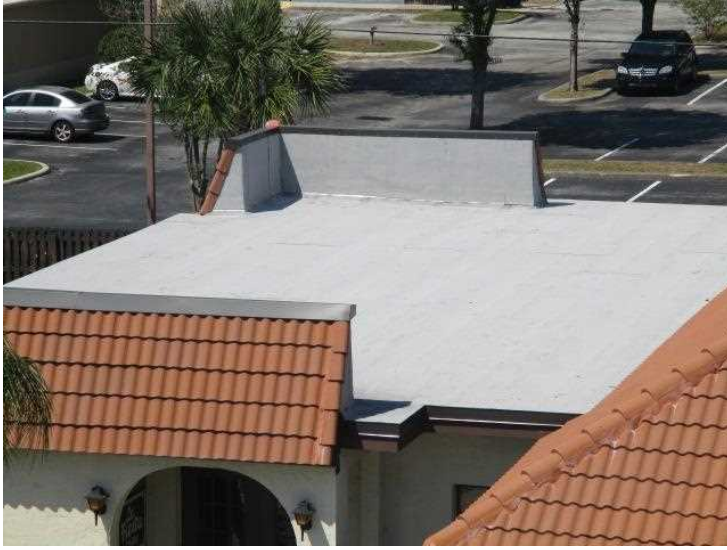
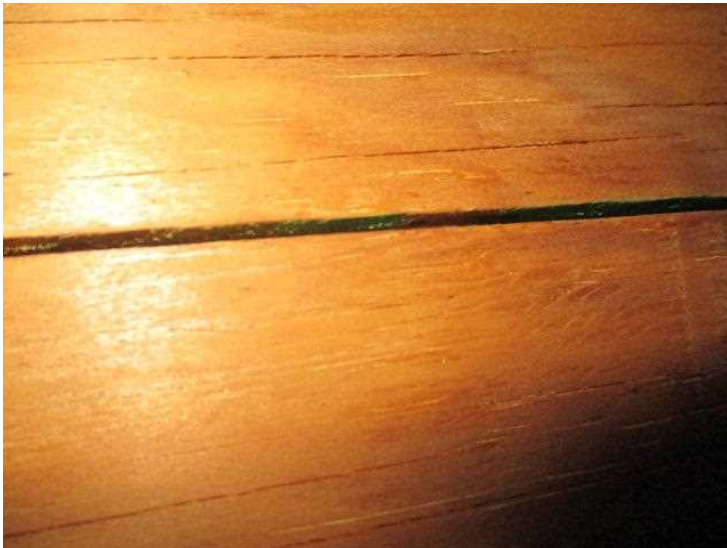
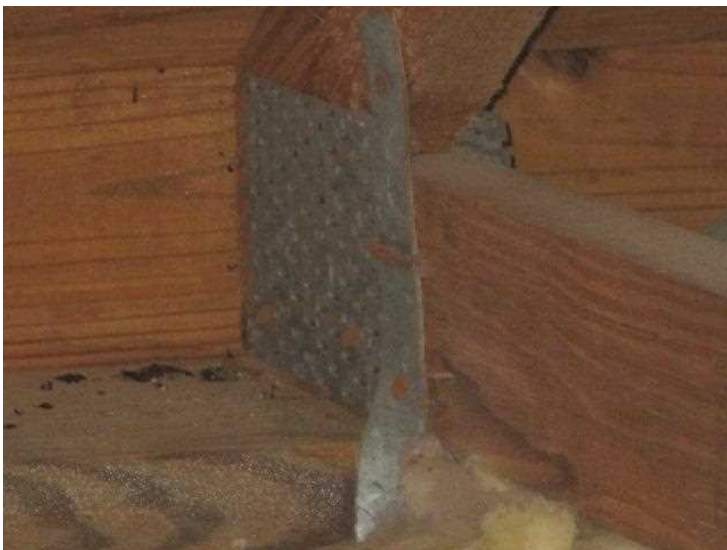
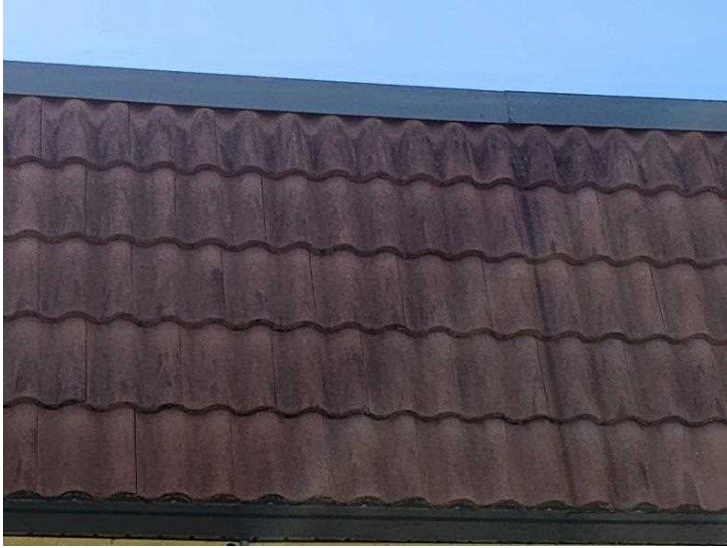
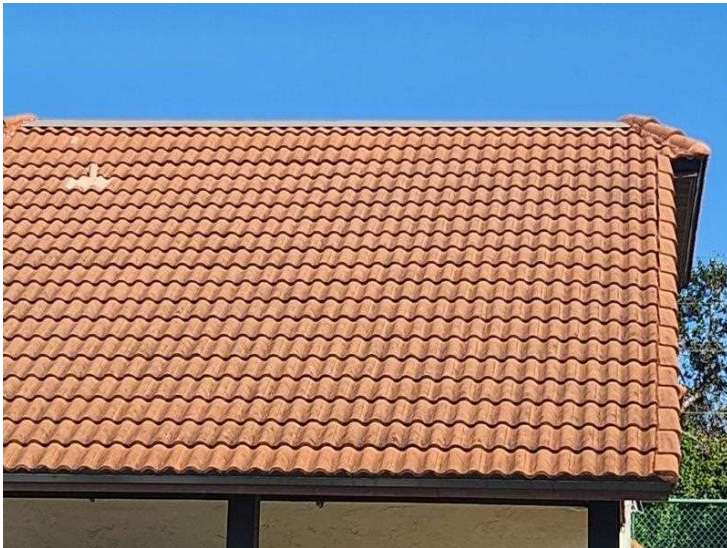
Roof Construction

- 6. SWR:** **Yes**
Comments: SWR was verified at time of inspection. The Secondary Water Resistance verified is a self-adhering peel and stick.
- 7. Opening Protection:** **None or Some Glazed Openings**
Comments: No opening protection verified at the time of inspection.
