Windstorm Mitigation Report (OIR-B1-1802)

Casa Del Sol Association, Inc.

2420 Winding Creek Blvd, Units 101-108, 201-208

As of 10-14-2024 | FPAT File# MUD2423385

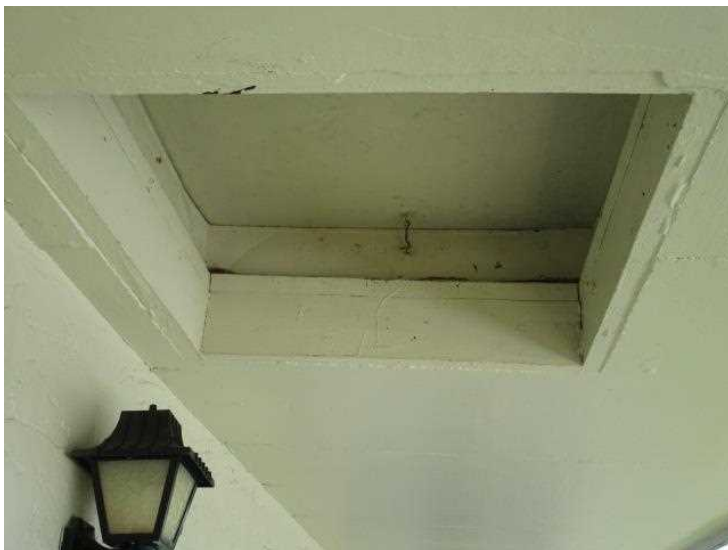
Roof Construction

- 3. Roof Deck Attachment:** **Reinforced Concrete Roof Deck**
Comments: Inspection verified a roof structure composed of cast-in-place or pre-cast structural concrete designed to be self-supporting and integrally attached to the wall / support system.

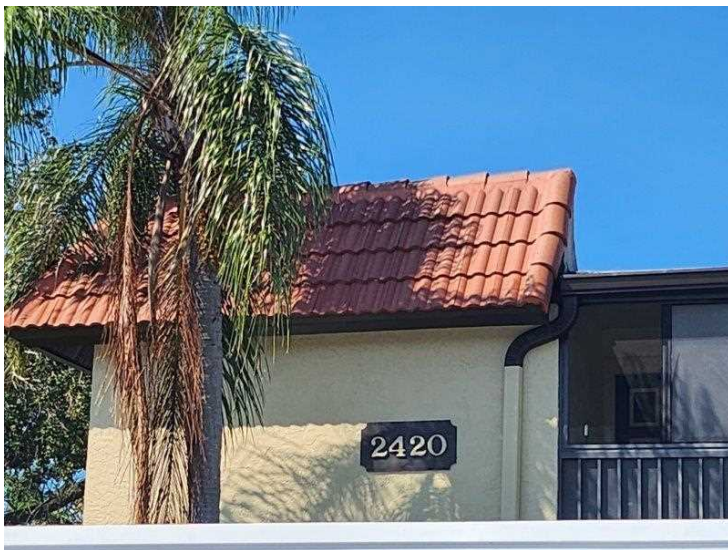
Roof Construction

- 4. Roof to Wall Attachment:** **Structural**
Comments: Inspection verified a roof structure composed of cast-in-place or pre-cast structural concrete designed to be self-supporting and integrally attached to the wall / support system.
