## Windstorm Mitigation Report (OIR-B1-1802)

Casa Del Sol Association, Inc.

2440 Winding Creek Blvd, Units 101-308

As of 10-14-2024 | FPAT File# MUD2423385

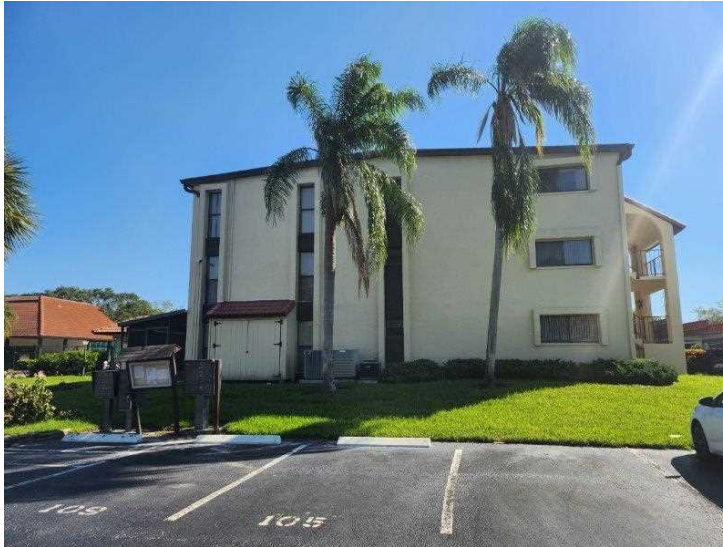
Roof Permit Information

- 2. Roof Covering:** **FBC Equivalent**  
Comments: The flat roof covering was replaced in 2018. The roof permit was confirmed and the permit number is CW18-15073. The pitched roof covering was replaced in 2023. The roof permit was confirmed and the permit number is EBP-23-19120. This roof was verified as meeting the building code requirements outlined on the mitigation affidavit.

Case / Application / Permit Number Type / Classification	CW18-15073 COMBOWEB RFCFLT: Roofing - Commercial Flat BLDG: Building Department 2440 WINDING CREEK BLVD Pinellas County, FL
Address	
Parcel Number	<a href="#">19281614063000001</a>
File Date	2018-11-01
Status	FINALED
Status Date	N/A
Valuation	\$62,800.00
Fees	\$219.55
Payments	\$219.55
Balance	\$0.00
Description	FL 2533.1 Flat 123 sq

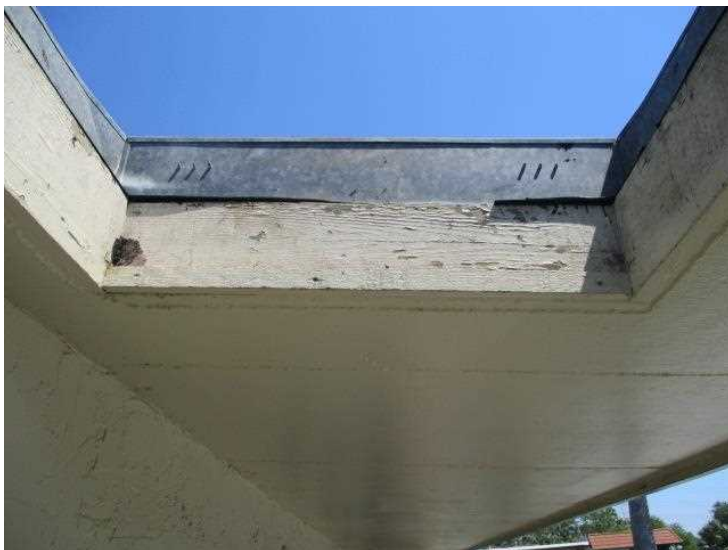
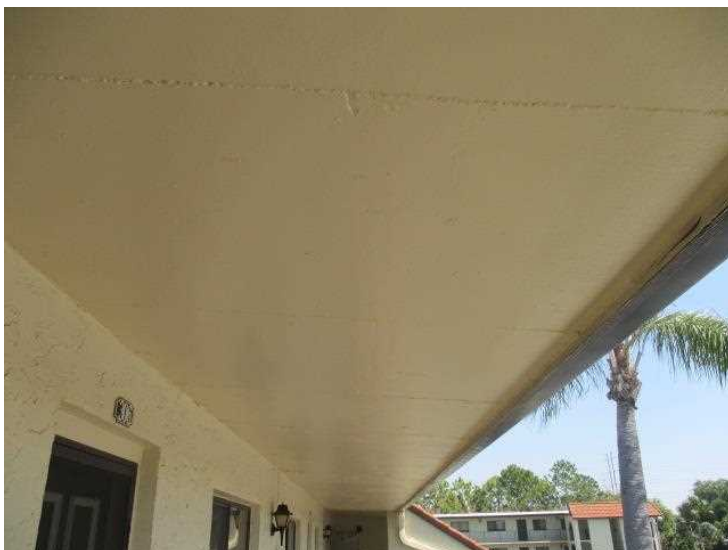
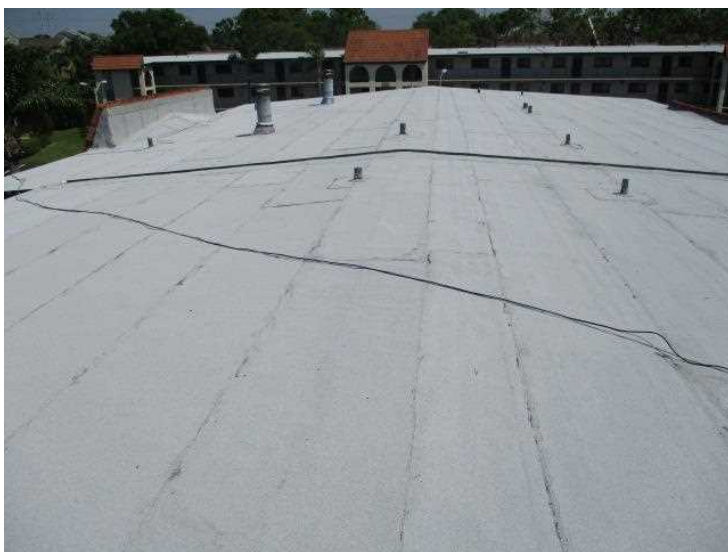
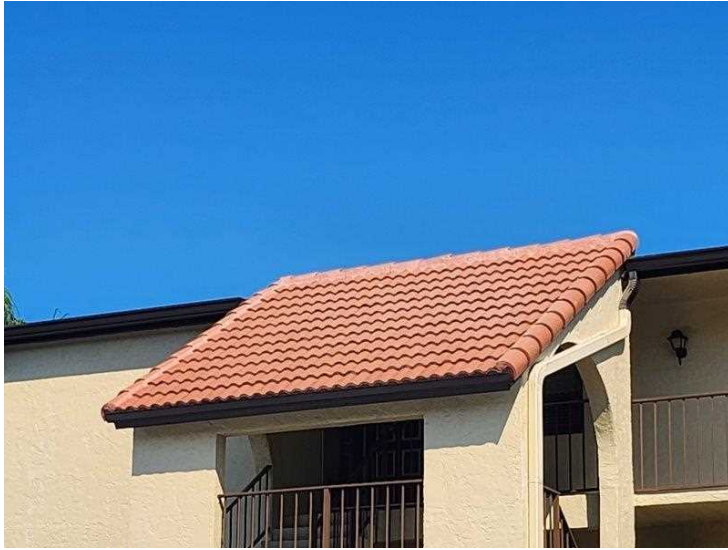
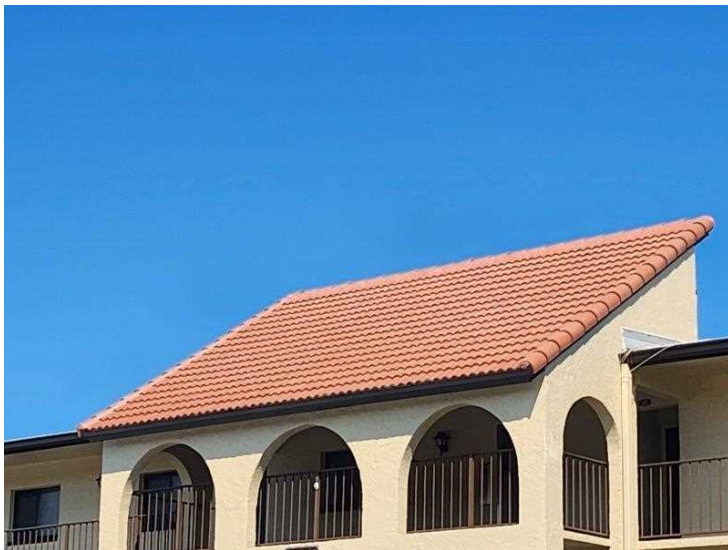
Roof Construction

- 3. Roof Deck Attachment:** **Reinforced Concrete Roof Deck**  
Comments: Inspection verified a roof structure composed of cast-in-place or pre-cast structural concrete designed to be self-supporting and integrally attached to the wall / support system.

- 4. Roof to Wall Attachment:** **Structural**  
Comments: Inspection verified a roof structure composed of cast-in-place or pre-cast structural concrete designed to be self-supporting and integrally attached to the wall / support system.

- 5. Roof Geometry:** **Flat Roof**  
Comments: Inspection verified flat roof shape, refer to attached photographs.
- 6. SWR:** **No**  
Comments: SWR does not apply to reinforced concrete roof decks.
