Windstorm Mitigation Report (OIR-B1-1802)

Casa Del Sol Association, Inc.

3077 Casa Del Sol Cir, Units 101-309

As of 10-14-2024 | FPAT File# MUD2423385

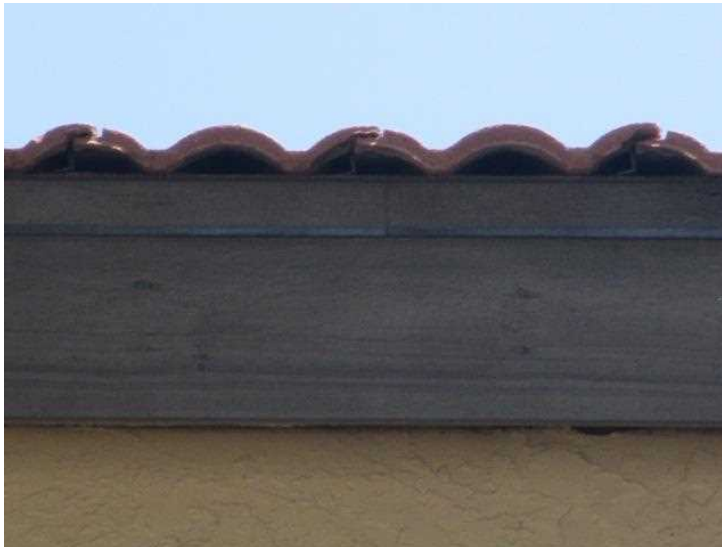
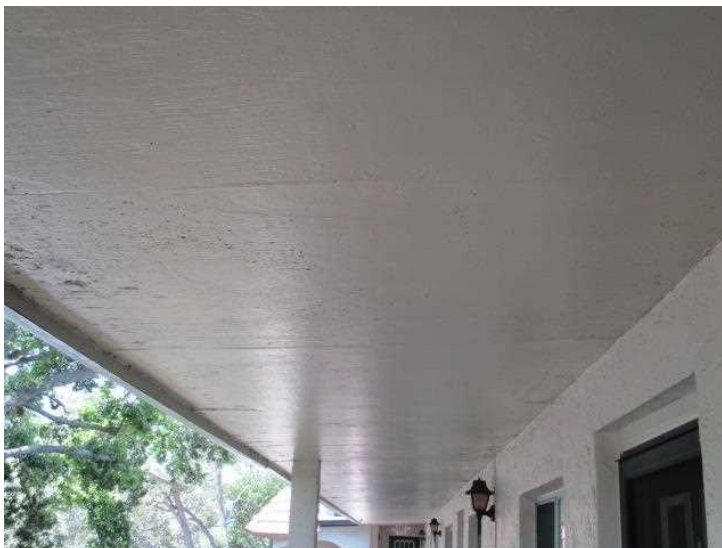
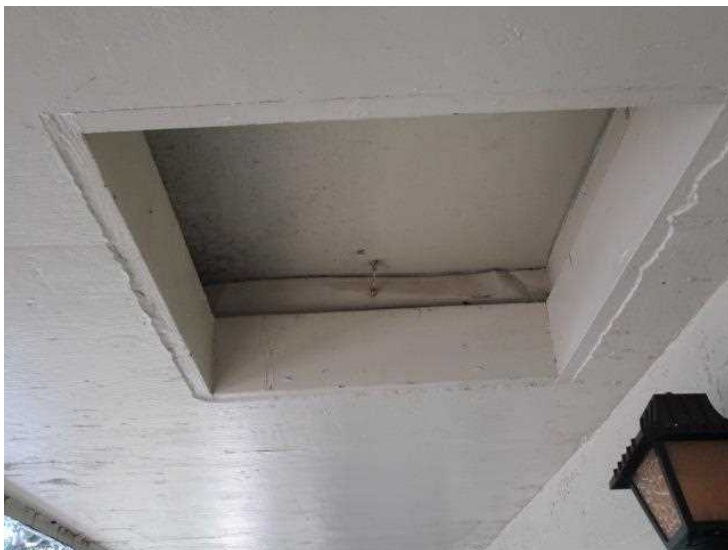
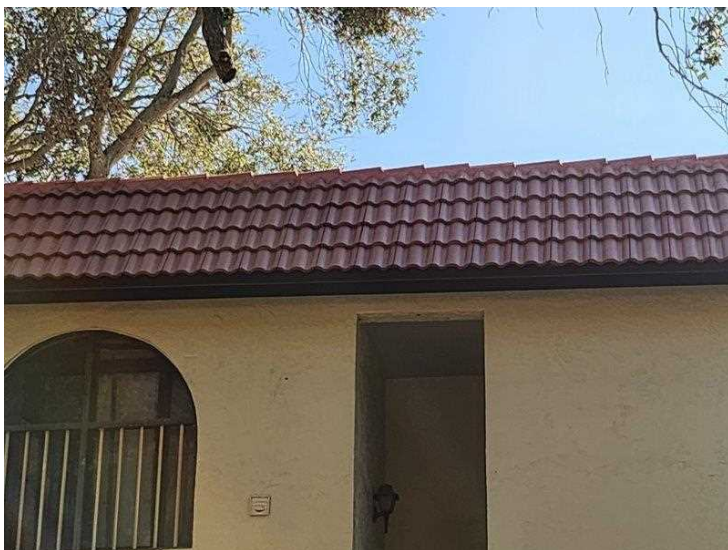
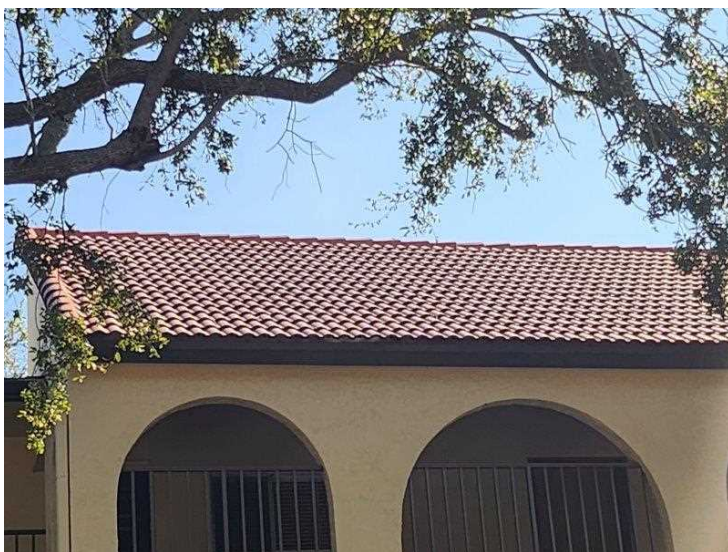
Roof Construction

- 3. Roof Deck Attachment:** **Reinforced Concrete Roof Deck**
Comments: Inspection verified a roof structure composed of cast-in-place or pre-cast structural concrete designed to be self-supporting and integrally attached to the wall / support system.

- 4. Roof to Wall Attachment:** **Structural**
Comments: Inspection verified a roof structure composed of cast-in-place or pre-cast structural concrete designed to be self-supporting and integrally attached to the wall / support system.
