Windstorm Mitigation Report (OIR-B1-1802)

Casa Del Sol Association, Inc.

3055 Casa Del Sol Cir, Units 101-309

As of 10-14-2024 | FPAT File# MUD2423385

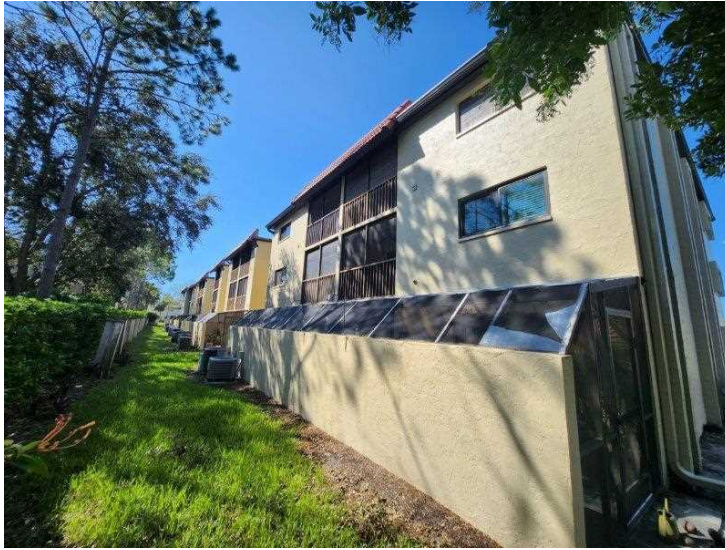
Exterior Elevation

- 7. Opening Protection:** **None or Some Glazed Openings**
Comments: No opening protection verified at the time of inspection.

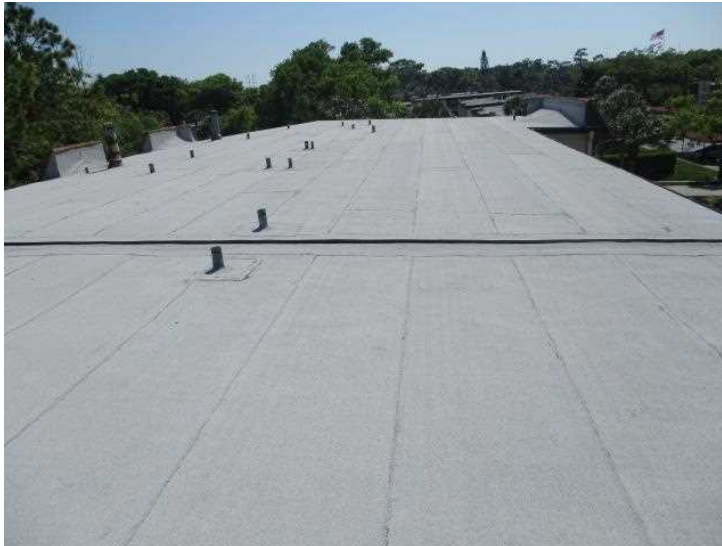
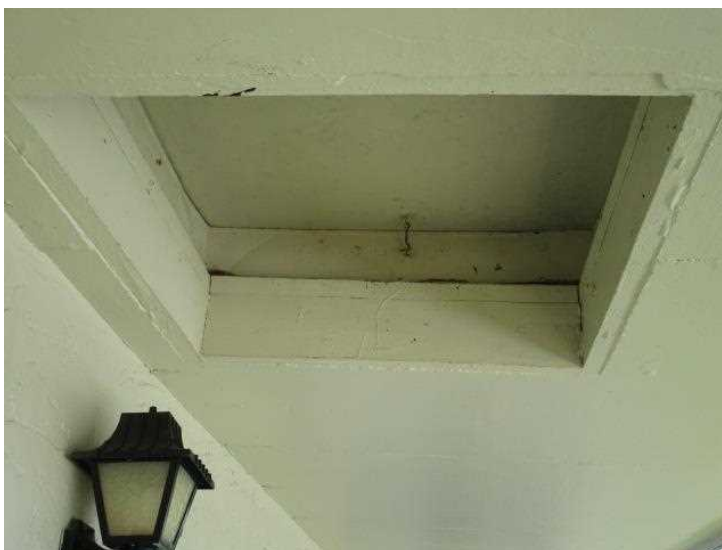
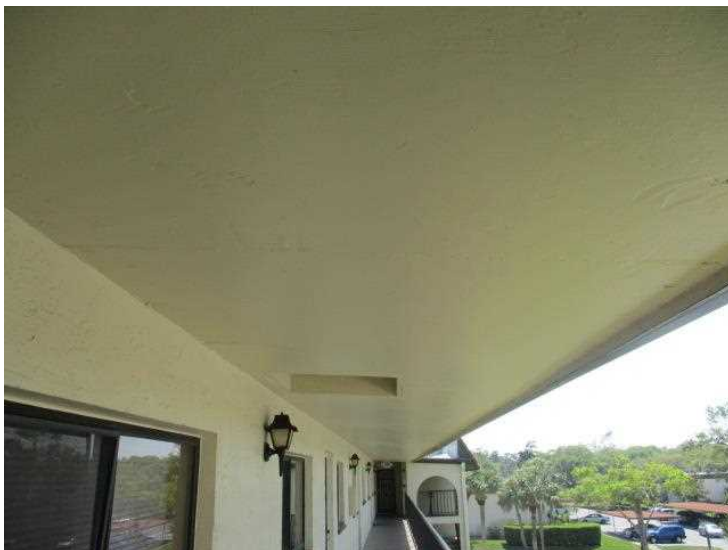
Roof Construction

- 3. Roof Deck Attachment:** **Reinforced Concrete Roof Deck**
Comments: Inspection verified a roof structure composed of cast-in-place or pre-cast structural concrete designed to be self-supporting and integrally attached to the wall / support system.

- 4. Roof to Wall Attachment:** **Structural**
Comments: Inspection verified a roof structure composed of cast-in-place or pre-cast structural concrete designed to be self-supporting and integrally attached to the wall / support system.

- 5. Roof Geometry:** **Flat Roof**
Comments: Inspection verified flat roof shape, refer to attached photographs.
- 6. SWR:** **No**
Comments: SWR does not apply to reinforced concrete roof decks.
