Windstorm Mitigation Report (OIR-B1-1802)

Casa Del Sol Association, Inc.

2420 Winding Creek Blvd, Units 109-112, 209-212

As of 10-14-2024 | FPAT File# MUD2423385

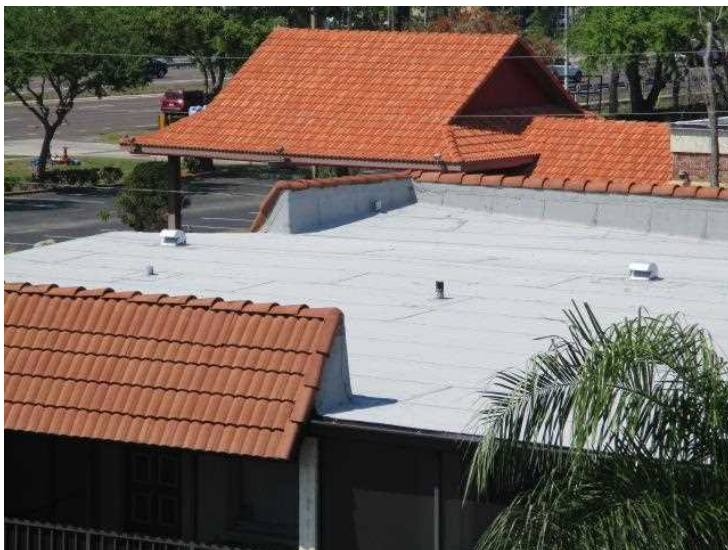
Roof Construction

- 3. Roof Deck Attachment:** **Reinforced Concrete Roof Deck**
Comments: Inspection verified a roof structure composed of cast-in-place or pre-cast structural concrete designed to be self-supporting and integrally attached to the wall / support system.

- 4. Roof to Wall Attachment:** **Structural**
Comments: Inspection verified a roof structure composed of cast-in-place or pre-cast structural concrete designed to be self-supporting and integrally attached to the wall / support system.

- 5. Roof Geometry:** **Flat Roof**
Comments: Inspection verified flat roof shape, refer to attached photographs.
- 6. SWR:** **No**
Comments: SWR does not apply to reinforced concrete roof decks.
